4 - POLICE DEPARTMENT

May 14, 2014

Building Assessment for Existing Swanzey Police Department

34 Eaton Road
Swanzey, New Hampshire 03446

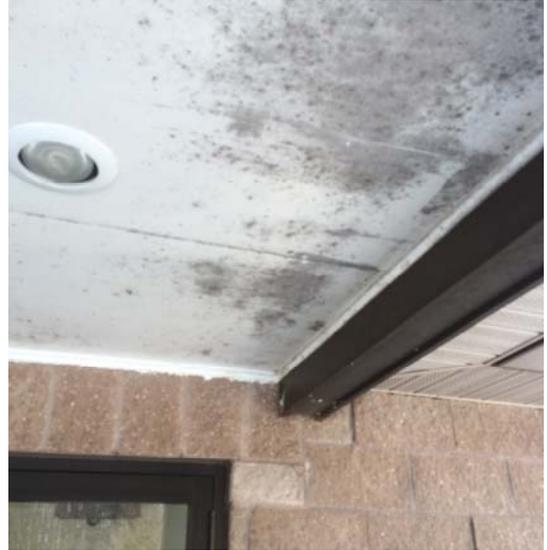
There is significant soffit mold/mildew build up at the exterior entry. The wood trim on the exterior posts is too close to the ground and has rotted.

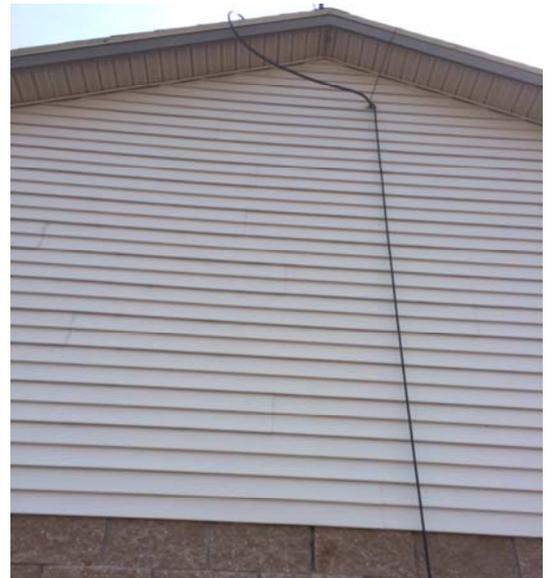
On the west wall there is what appears to be an abandoned antenna wiring that can be removed.

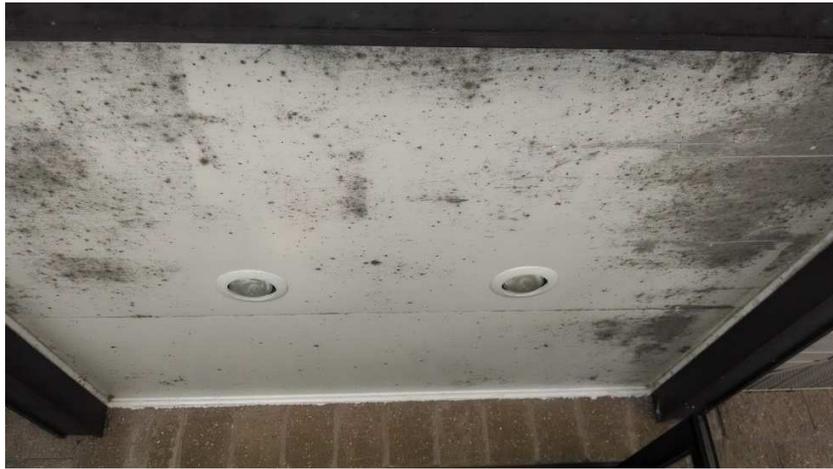
Photograph 1: Mold / Water Damage Above Entry Door

There is a small overhang in front of the main entry doors. On the ceiling of the overhang there is evidence of water damage/ mold.

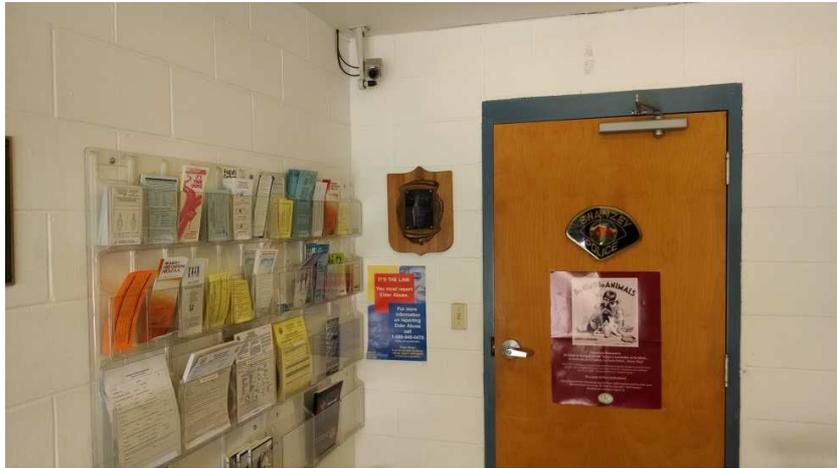
Photograph 2: Entryway Showing Non-Reinforced Door

The door from the entryway to the main area of the department is not reinforced. There is a camera in the entryway. The entryway does not provide a desk/chair or writing area for citizens who might want to make a police report.

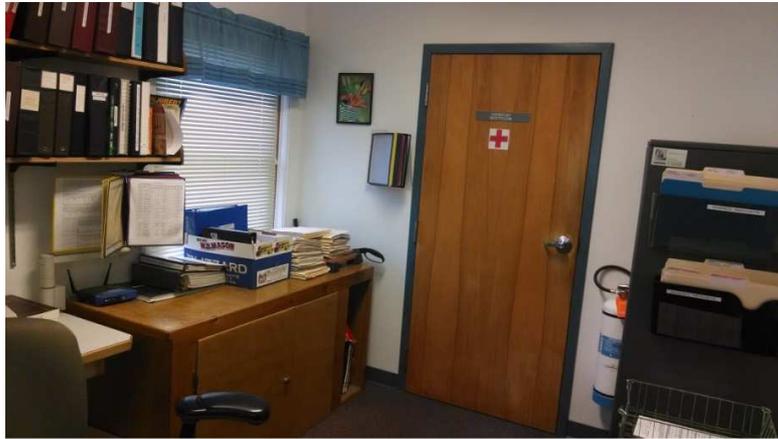
Photograph 4: Entrance ADA Compliant Restroom in Administrative Office

An ADA complaint restroom is located in the front desk area as this was the area planned for dispatch. There are not any public restrooms in the area adjacent to the entryway (previously described) nor in the training room. When community members use the training room, they must enter the police area in order to use another ADA compliant restroom.

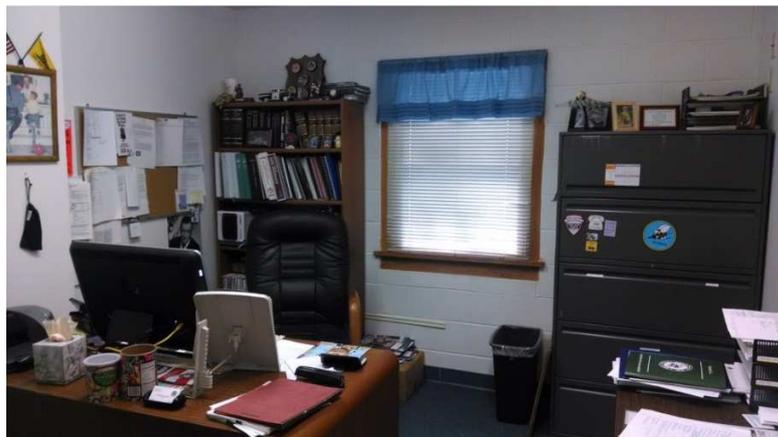
Photograph 5: Chief's Office

The chief's office has a traditional window that is not reinforced or alarmed.

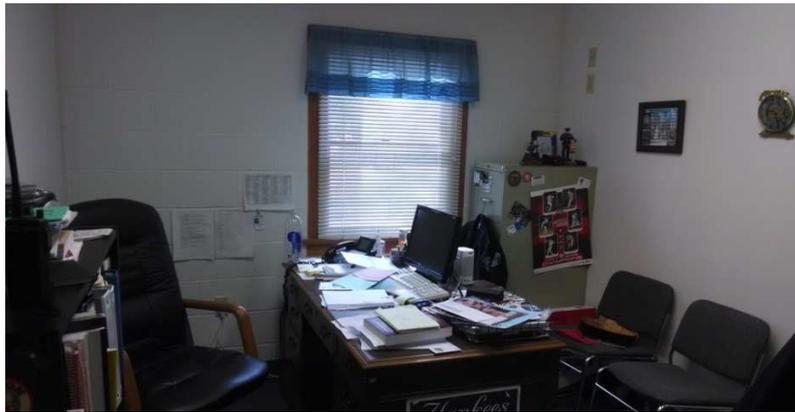
Photograph 6: Lieutenant's Office

The lieutenant's office is in the main hallway appropriately located next to the chief's office. The office space barely allows for the desk, file cabinet, and chairs for employees to use should they need to meet with the lieutenant. Moreover, if the department experiences its expected growth, it would be difficult for two lieutenants to share the office even if working different shifts, as there is not any additional storage capacity.

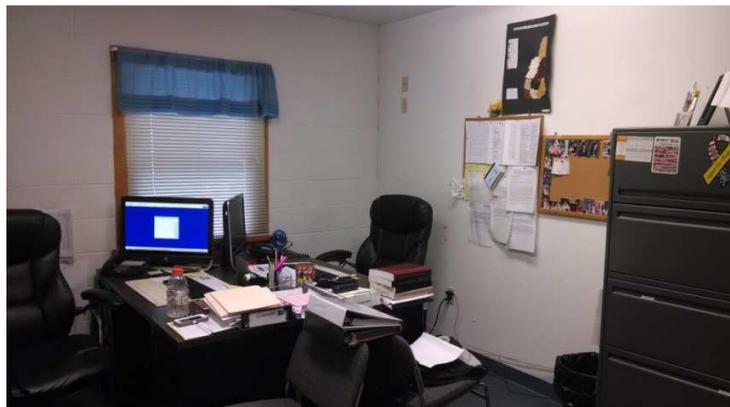
Photograph 7: Sergeant's Office

The sergeant's office is at the end of the main hallway adjacent to the lieutenant's office. Currently two sergeants share the space. The area has one file cabinet and two additional chairs in case a sergeant needs to meet with an officer. The small space however, does not allow for a small table prohibiting sergeants and officers from reviewing material with one another. To the right of the file cabinet, there is a storage closet that was added after construction of the building. The layout of the electrical in the room is inadequate and electrical cords run in areas close to where people walk.

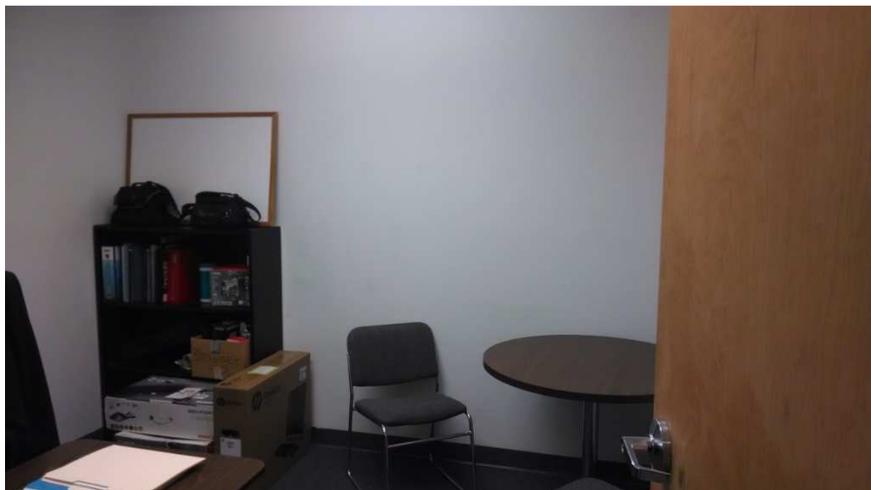
Photograph 9: Detective's Office

The detectives office is adequate in size.

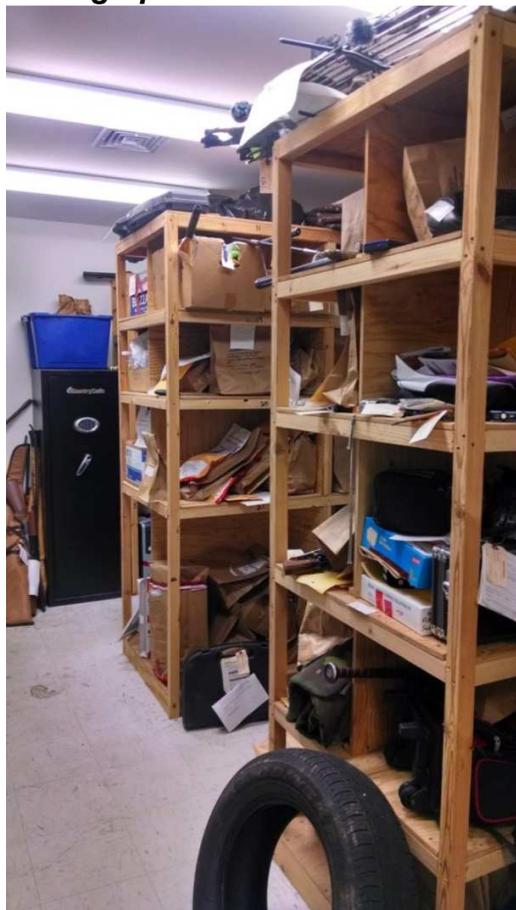
Photograph 13: Evidence Room

The evidence room is located off the patrol area. Procedures are in place to ensure proper chain of custody. However the department is reaching capacity in the evidence room.

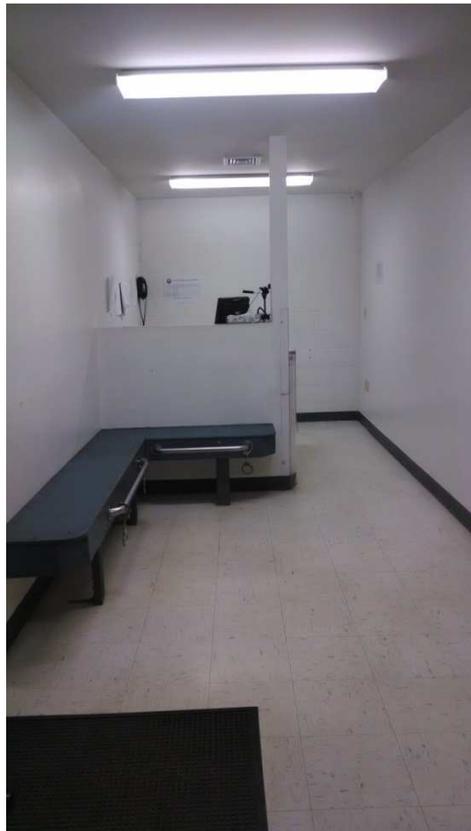
Photograph 14: Booking and Holding Area

The intoxilizer is to the rear of the booking area. If someone is already in the holding area, an officer has to wait until the area is clear before using the equipment.

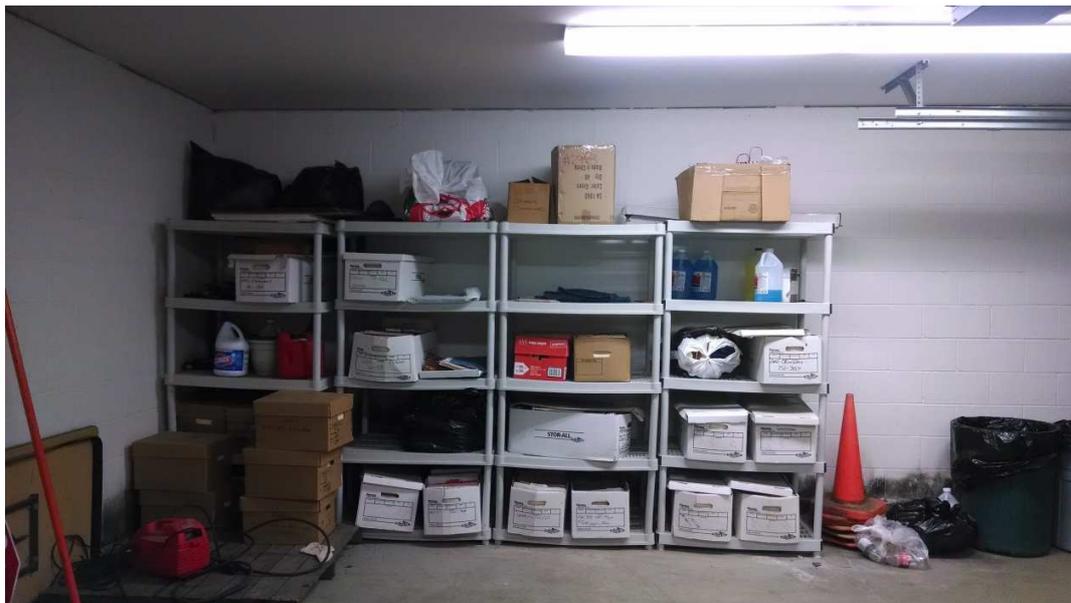
Photograph 15: Sally Port – Right Hand Side Storage

Currently the sally port also acts a storage location. A sally port is an improper storage location and creates a significant safety concern. Officers must bring detainees into the building through the sally port and there are several items which could become a weapon.

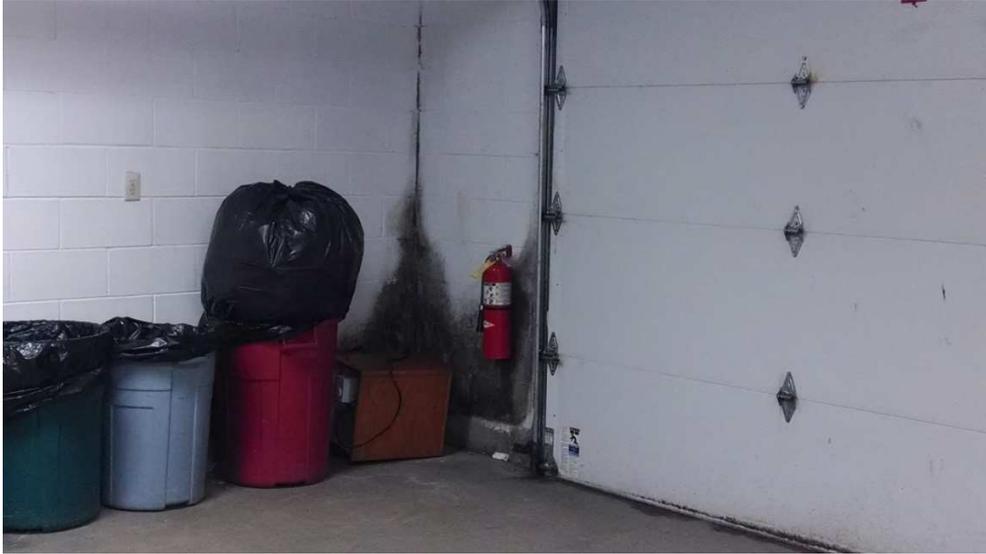
Photograph 16: Sally Port – Right hand Side Mold

Mold is present in several areas. Despite efforts by the department to remove the mold, it continually reappears.

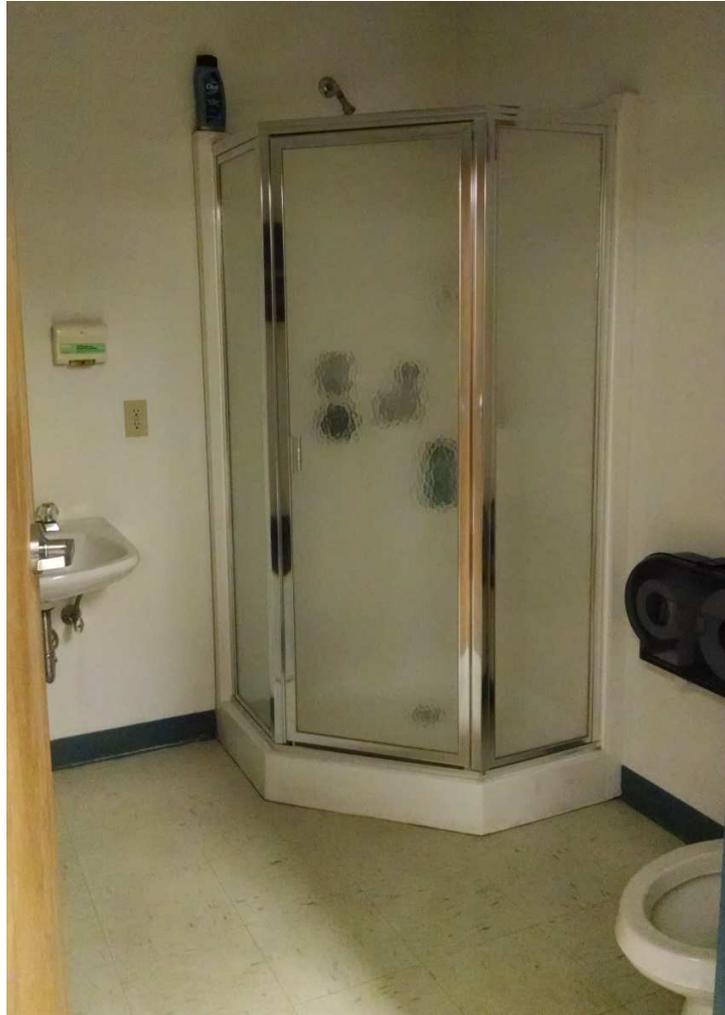
Photograph 19: Restroom and Shower Facility

There is a single shower located in a restroom across the patrol room. If an officer wants to use the shower, they must cross the patrol area, in which a detainee could be sitting.

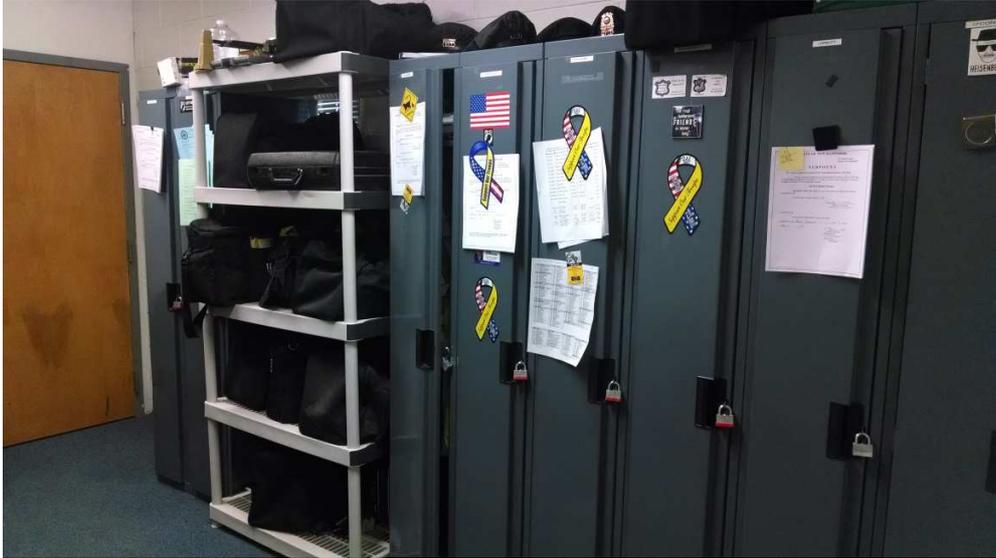
Photograph 20: Officer Lockers

The department lacks proper locker room facilities. The lockers are located in a converted office off the patrol room. In addition to housing the lockers, this room is also used for file storage. The lockers themselves are substandard and do not provide ventilated space for vests or boots.

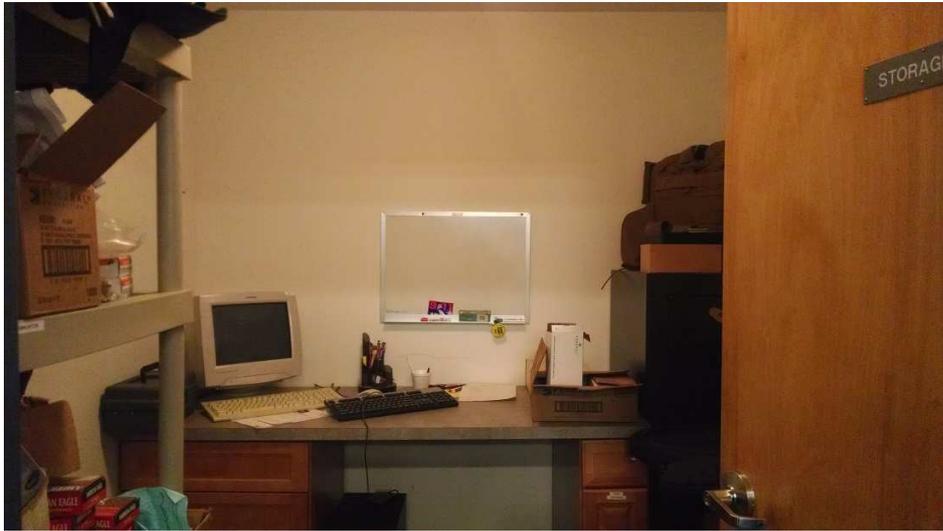
Photograph 25: Armory – Inside Training Room

The armory is located in what is essentially a closet in one corner of the training room. The armory does not have a reinforced door nor a camera monitoring entry. This presents a safety concern.

The armory is located in the training room and is accessed through a simple wooden door. The location and space is inappropriate.

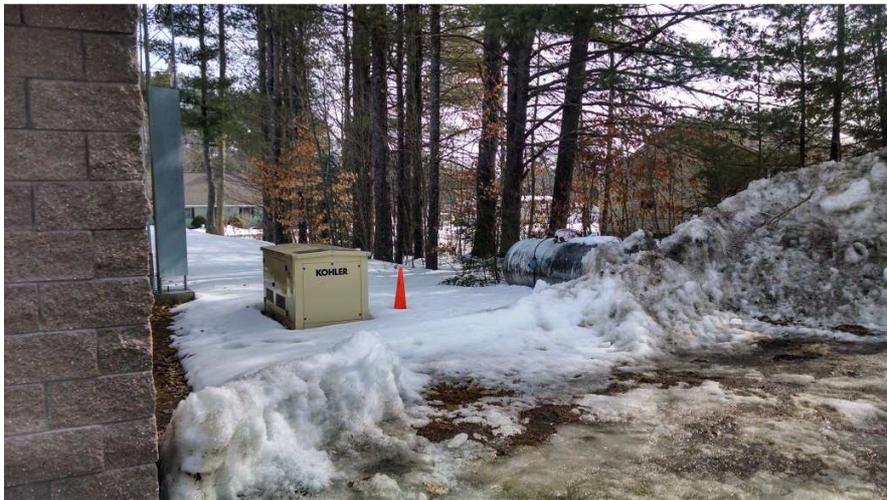
Photograph 26: Building Utilities – Unprotected

Building utilities are in plain view of the street, but on the blind side of the building. There are not any cameras in the area, which is easily accessible from neighboring properties.

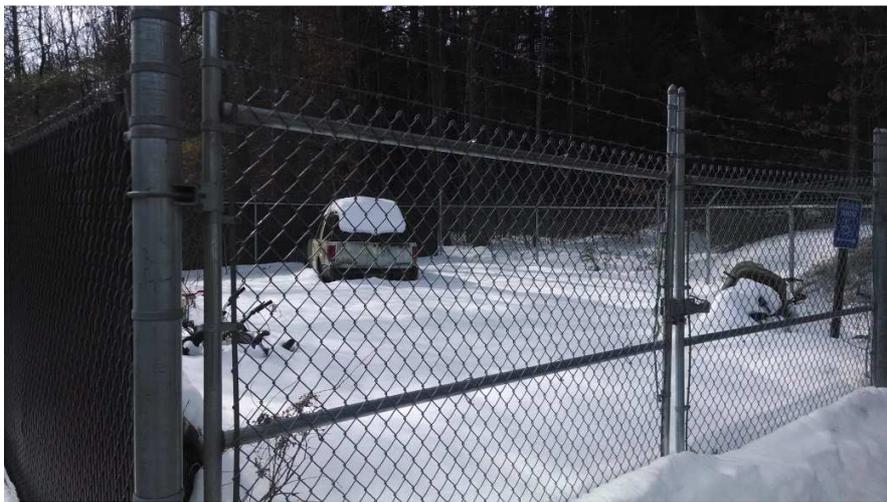
Photograph 27: Impound

The impound is located to the rear of the property past the cruiser parking. The space is adequate in size, but does not afford covered storage of items that might be larger and require storage outside rather than in the evidence room. The impound is not fully monitored by cameras.

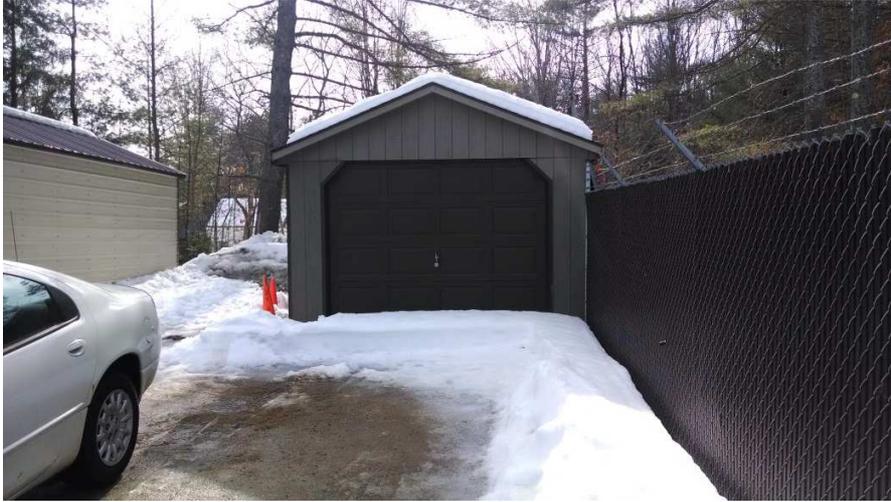
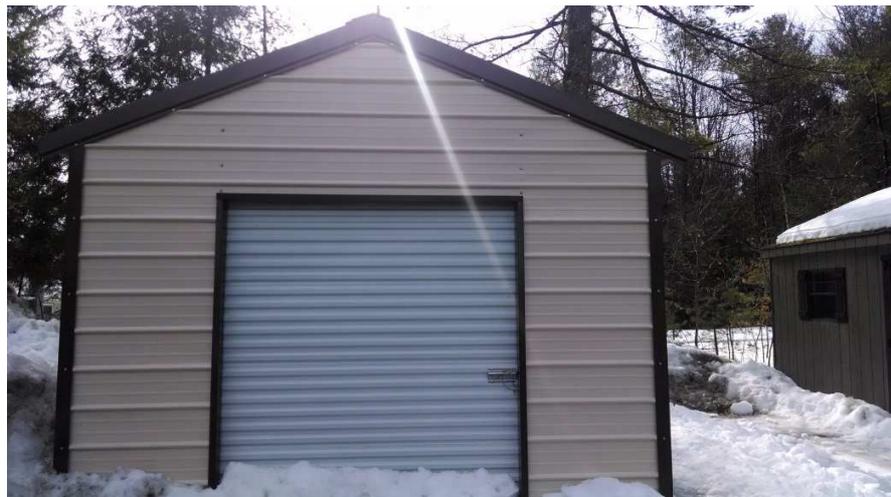
Outside the building, next to the impound area are two storage units. They are essentially sheds that have been placed on the property to address the lack of interior storage space. The sheds are not monitored by cameras, are not weather or rodent proof and are susceptible to a range of temperatures.

Photograph 28: Exterior Storage II – Unsecured

Photograph 29: Exterior Storage II – Unsecured

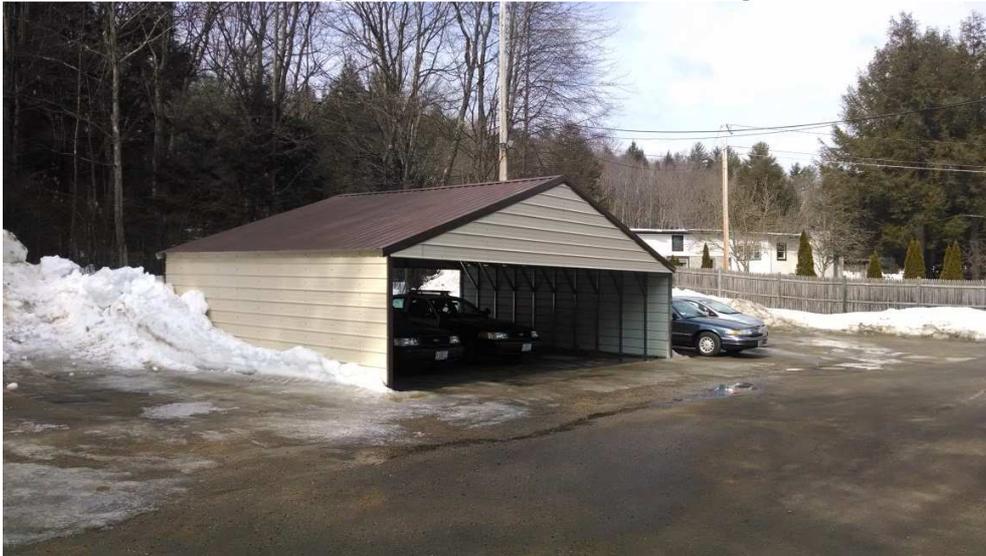
Photograph 30: Cruiser Parking

Cruiser parking is located at the back of the property. While separated by a wooden fence, a neighbor's house is located in the same area. While care is taken to keep noise down by not testing the cruisers lights and sirens during shift change, the cruiser come and go at all hours of the day.
