A) BUILDING / SITE ASSESSMENT, WITH EXISTING SITE PLAN.

May 14, 2014

Building Assessment for the Existing Swanzey Department of Public Works

Pine Street
Swanzey, New Hampshire 03446

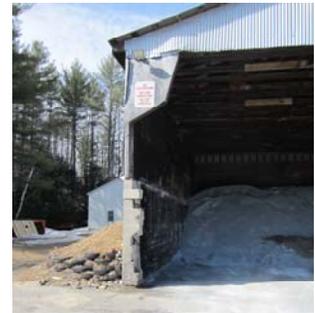
The structure of the salt shed is in very poor condition. The photos show the damage and deficiencies clearly. Many of the wood trusses are broken and poorly repaired. The concrete and masonry foundation is also cracked and banged up. A date on a concrete pier reads 1965. According to some, there was a structure at the site without a roof prior to that date. The shed is also poorly located for use of the entire site. Expansion of other facilities is hampered by this facility. Therefore, it is not recommended the salt shed be significantly repaired. A sound properly constructed salt storage facility really needs to be constructed at a more appropriate location. The site appears to have sufficient room for proper siting.

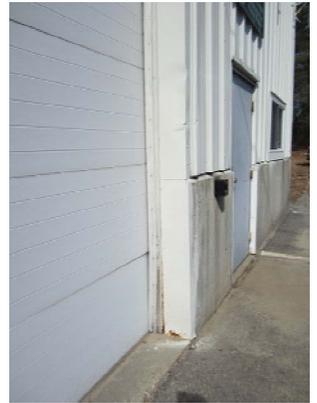
The DPW Garage/Office building appears to need some exterior refinishing. The exterior metal siding is visibly damaged (dented/punctured) at numerous locations. The concrete foundation wall appears to be in good condition with no visible damage. The roof could not be examined closely, however, appeared to be in fair shape.

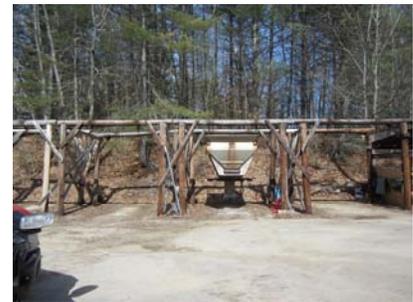
Scaffolding structures were created using pilings (possibly coated with creosote). They appear to be functioning properly and are in fair condition.

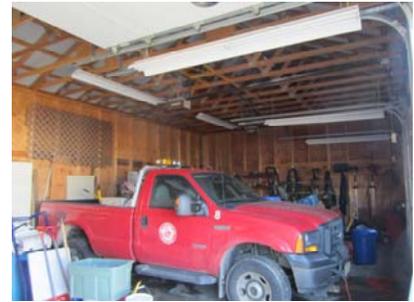
The wall construction of the garage appears to consist of uninsulated 2x6 wall framing, plywood sheathing, and vertical wood siding. The roof structure uses wood trusses with an uninsulated metal roof. The floor is a concrete slab on grade. The interior is exposed wall and roof framing and appears to be in very good/like new condition. The concrete slab appears to be in good shape as well. No water infiltration was evident.

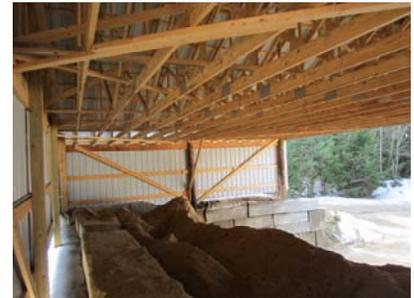
See Exterior Architectural Condition on previous pages for condition of foundation. The interior wall and roof framing is exposed and appears to be mostly in very good condition. The roof framing consists of wooden trusses. The wall framing is a combination of 6x6 posts and large diameter creosote (or similar) coated pilings. There is some horizontal wooden bracing tying it all together. All existing finishes appear to be in good shape.
