### **6 - RECYCLING CENTER**

**A) BUILDING / SITE ASSESSMENT, WITH EXISTING SITE PLAN.**

May 14, 2014

## Building Assessment for the Existing Swanzey Recycling Center

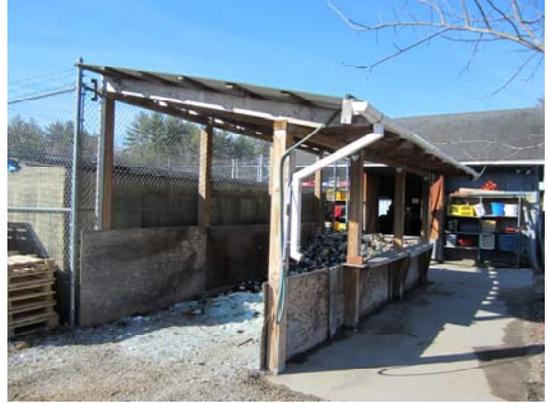
Structure 4: Glass Storage Outbuilding:

The Glass Storage structure is around 190 sf.

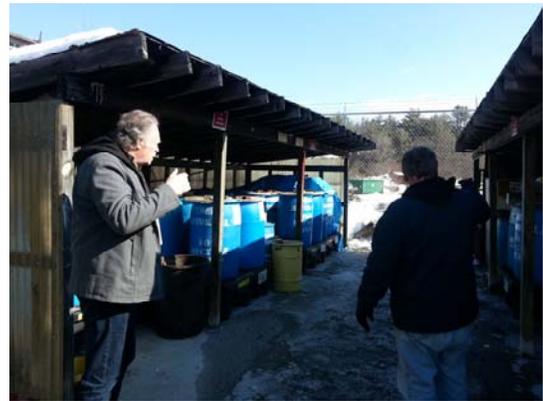
Structure 5: Liquid Waste (used oil, gas, paint, etc.)

This area consists of a 780 sf Fenced in Concrete pad with 2 – Three sided 193 sf storage sheds which appear to be utilized to store batteries and hazardous liquids such as: oil, paint, and gas.

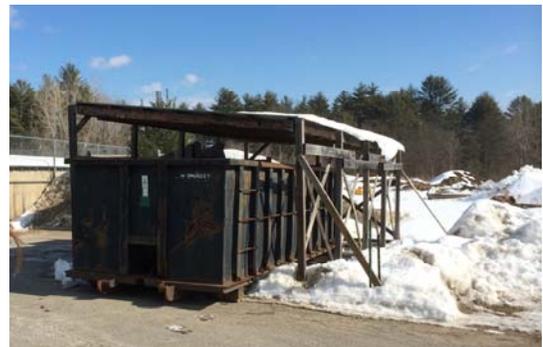
Structure 6: Steel Can Area:

The Steel Can area consists of a 30 Yard Roll off Dumpster that is protected from the elements by a roof structure. The roof covers a 300 sf area.

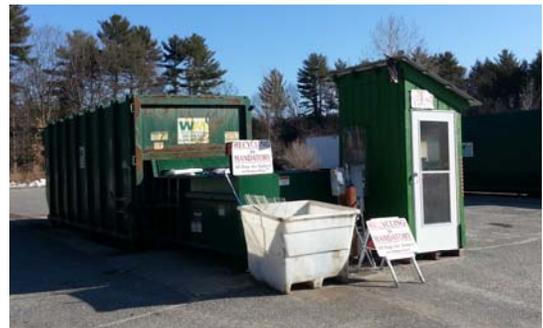
Structure 7: Employee Shed:

The Employee shed is a 12 sf shed located adjacent to the compactors. This shed is used to supervise the operation of the compactors and monitor the waste being thrown into the compactors.

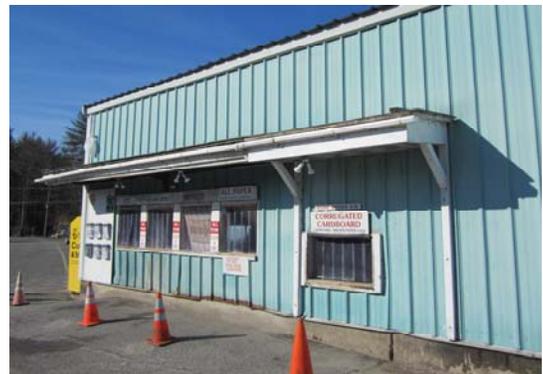
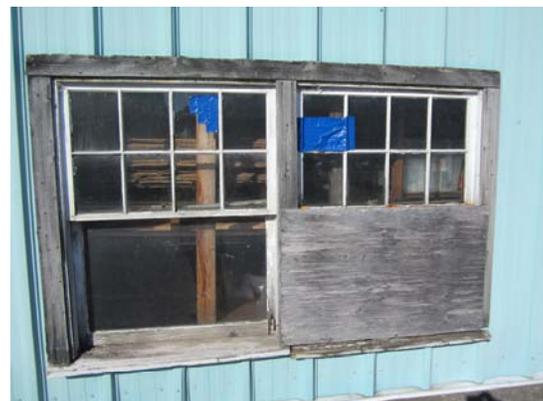
Structure 1: Recycling Center Main Building, Office, Sorting, and Storage:

The RC Main Building is a steel frame metal sided building with Poured Concrete foundation wall and slab. The roof is a metal roof and what could be seen from the ground appeared to be in fair to poor condition. There are several roof leak locations on the interior. The foundation wall appears to be in good condition given the age and use of the building. The metal skin of the building is fair in condition given its age and has some noticeable dents. At some locations (mostly near the sorting area) the metal siding is visibly corroded and is no longer keeping water out of the building. At the bottom of the metal siding (closest to grade) the termination flashing is in very poor condition. It is noticeably damaged in many areas and is even missing at some locations. The metal man doors on the building are showing signs of age, as many have begun to rust and corrode. Much of the metal trim around man doors,

windows, and garage doors is missing and or damaged. The windows are in very poor condition, as is the shed roof over recycling openings. The insulation on roof and walls is inadequate.

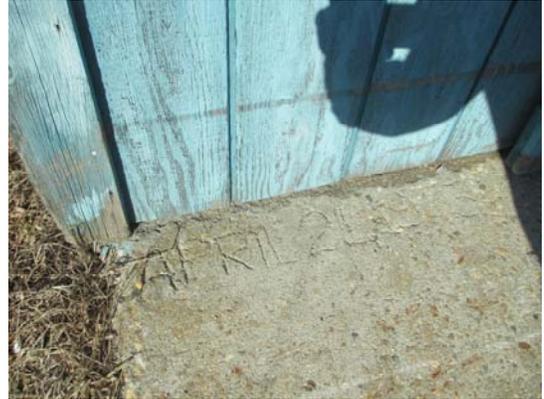
Structure 2: Bailed Storage Building:

This Bailed Storage Building's exterior walls appear to be 2x4 walls with plywood sheathing and stained vertical wood siding. It is recommended the siding be restrained to protect it from rot. There were some board already beginning to rot where in contact with the ground. The roofing material is asphalt shingles and appears to be in fair condition from what could be observed from the ground. There are two large sliding barn doors which appear to be in working order. The Foundations could not be physically seen during observation. The building may be slab on grade construction, however, further investigation would be required to determine this.

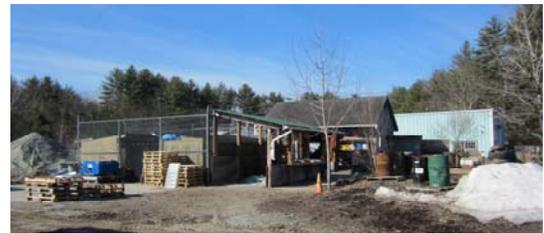
Structure 3: Glass Sorting Building:

The exterior walls appear to be 2x4 walls with plywood sheathing and stained vertical wood siding. It is recommended the siding be restrained to protect it from rot. Some of the wood trim and waterboard were rotted, especially near grade where long term water splashback is evident. The wooden waterboard is in direct contact with grade. The wood fascia board at eaves is rotted in some locations, and mold and mildew was observed near gutter locations. The roofing material is asphalt shingles and appears to be in fair condition from what could be observed from the ground. The metal drip edge is rusted at many locations. Only a small portion of the foundation wall could be observed. What could be see appears to be in fair condition, however, further investigation would be required to determine its condition.

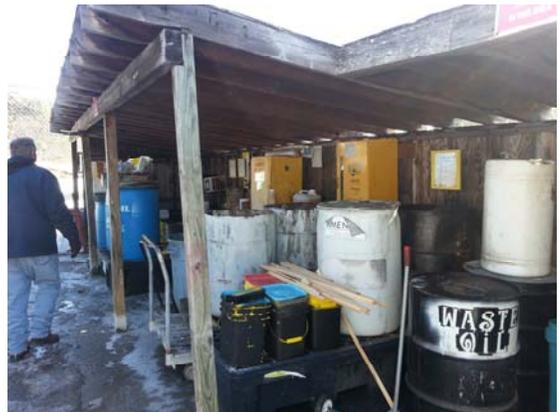
Structure 4: Glass Storage Outbuilding:

The Glass Storage structure consists of several 6x6 PT posts. The roof framing is 2x6 with a metal roof. 4x8 sheets of plywood is used to form walls between posts. The posts appear to have been installed within the last 10-15 years, however, the roof framing appears to be more aged. The plywood appears to be in very rough shape, and may fail in the near future. It appears the storage structure was placed atop an existing concrete slab. Slab appears to be in fair condition.

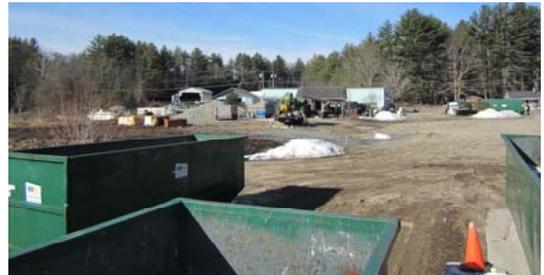
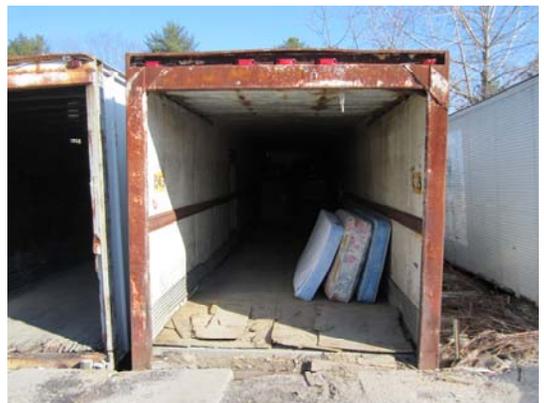
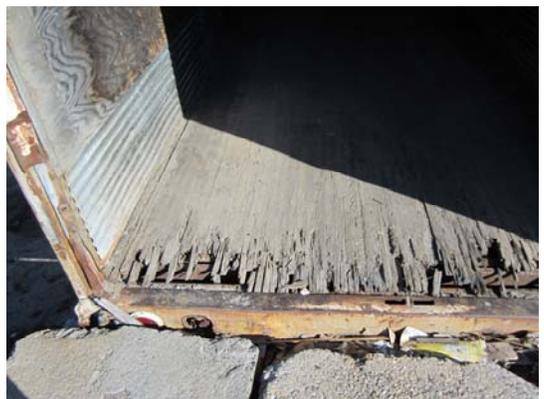
Tire Trailer: Exterior shows a great deal of rust, however, considering its function it seems in fair condition.

Misc. Trailer 1: Exterior shows a great deal of rust, however, considering its function it seems in poor condition. Floor is coming apart.

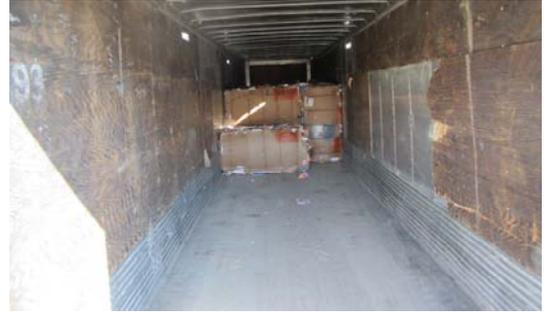
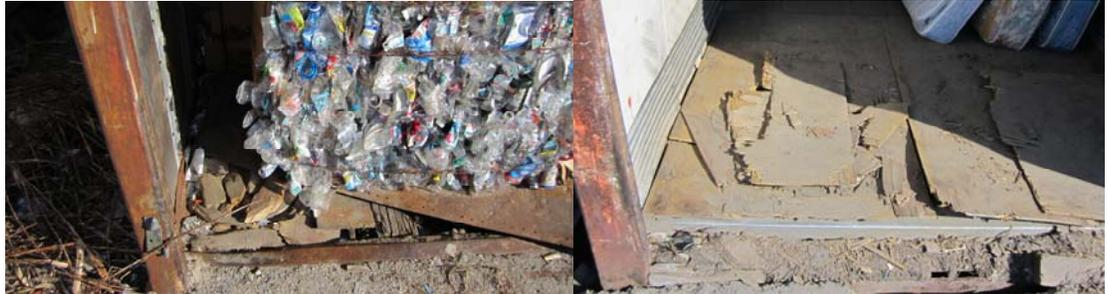
Misc. Trailer 2: Exterior shows a great deal of rust, however, considering its function it seems in poor condition. Floor is coming apart.

Misc. Trailer 3: Exterior shows a great deal of rust, however, considering its function it seems in poor condition. Floor is coming apart.

Trailers are loaded & unloaded frequently which is inefficient. Storage would be better in another location.
