2 - FIRE DEPARTMENT

- A) BUILDING / SITE ASSESSMENTS FOR CENTRAL, WEST, EAST STATIONS, WITH EXISTING SITE PLANS.**

Building Assessment for Existing Swanzey Central Fire Department

Building Assessment for Existing West Swanzey Fire Department

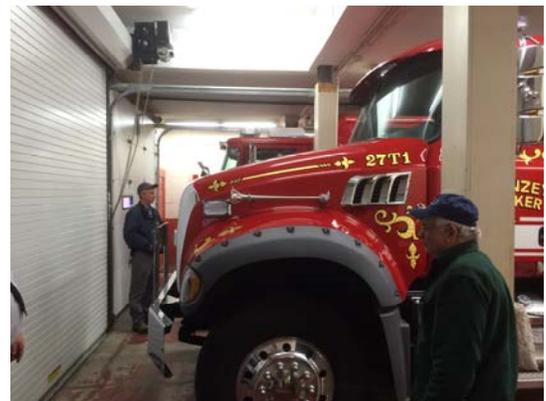
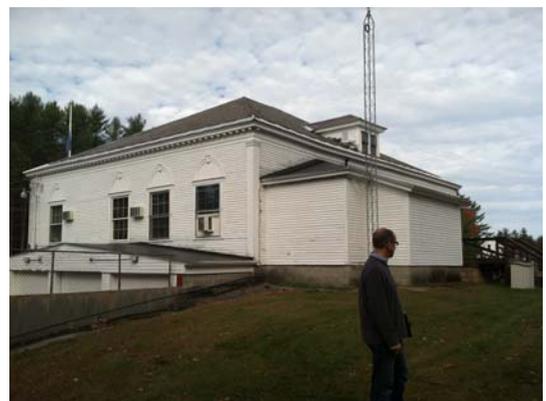
An addition to the south end of the basement needed to be built to accommodate fire trucks. The largest truck in the fire station needs to be fully loaded to pass through the garage doors. The floor slab appears sound.

The retaining wall on the east side of the fire station entrance needs to be rebuilt. The west side wall appears to be in good condition.

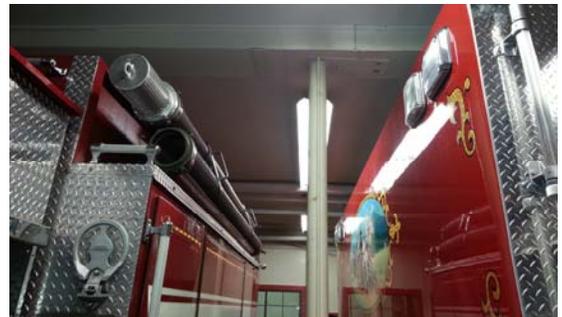
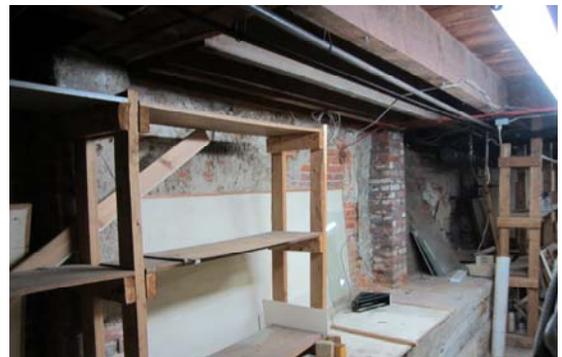
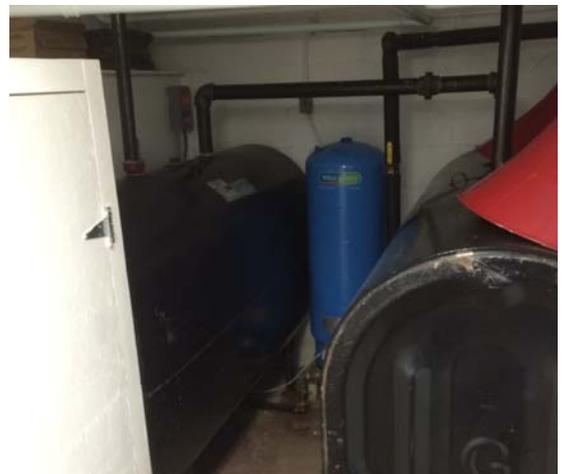
As previously mentioned, there was a 9' addition made to the south side of the building to provide adequate length for the fire trucks, at the time of the addition in the 1960s. The current apparatus vehicles barely fit the length provided. There are 3 bays, and 3 trucks kept in the Central Fire Station. The bays are defined by a column grid that supports the 12' on center structural bays in the building above. Steel is exposed and not properly fireproofed. The doors to the truck bays do not appear to have emergency stops or return controls. To either side of the truck bays are raised areas, which are not accessible. To the west are lockers at the truck floor elevation, and stairs up to a long mechanical room that runs the length of the west side of the building. There does not appear to be the required fire separation between the mechanical room and the truck bay area, or between the mechanical room and the Town Hall space above. On the east side of the truck bay is a raised single sex toilet, not accessible as it is up a flight of steps. There is another raised storage room, with the ceiling finish removed, on the east side of the building.

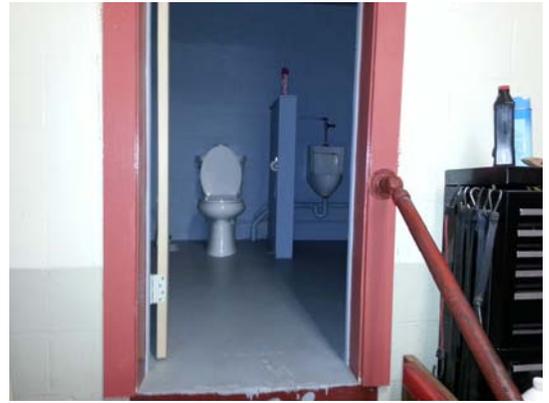
The ceilings of the fire station should be made to satisfy a 2-hour fire rating, as required by code between the different uses of this building. This room also houses hazardous materials and should be properly ventilated and separated with a fire-rated enclosure from the apparatus bays.

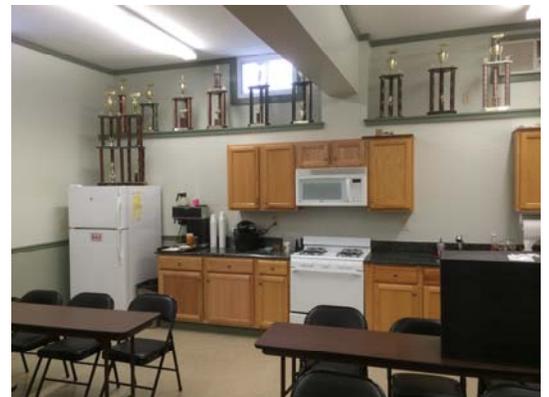
To the north of the apparatus bays is a large meeting room, with television on the west side and trophy storage and cabinets to the east. This room appears to be in good condition in terms of architectural finishes.

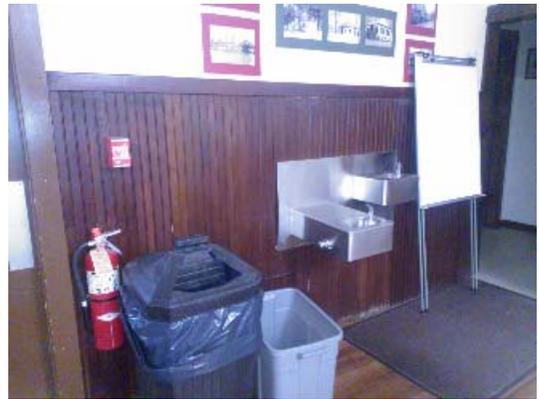
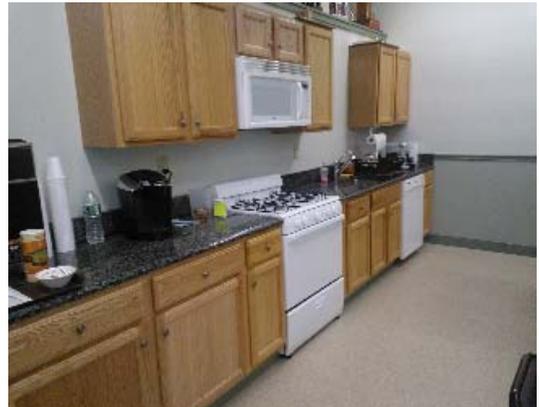
- The building shares a well water system with the adjacent library building.
- The building is on the Town septic system.
- There is a single toilet room downstairs, this room is not ADA compliant.
- The kitchen in the fire training room utilizes residential style systems and appliances.
- A second electric domestic water heater is located in the equipment room in the basement.
- A shop air compressor is located in the general room. The compressor is mounted on a vertical tank and appears to be in good condition. Air drops are located in the apparatus bays.

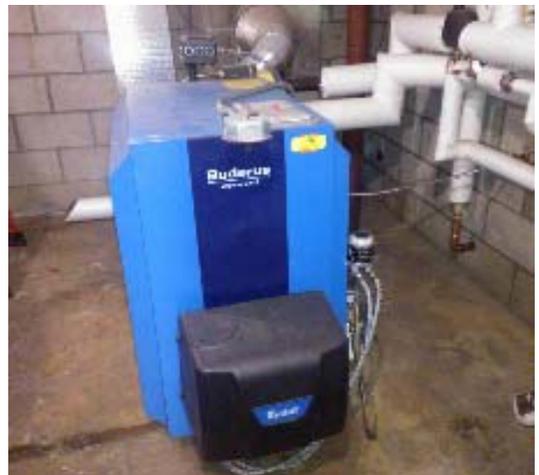
- The building is heated with an oil fired cast iron boiler Model Q215/3, 180 MBH output. There are two (2) 330 gallon oil tanks located in adjacent storage room. There are four (4) thermostatic zones.

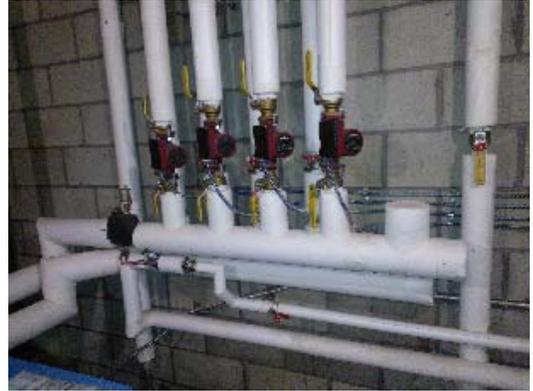
- Heating of the upper level is done with baseboard radiation. The apparatus bay is heated with unit heaters.
- There are no ventilation systems or tailpipe exhaust systems other than ceiling exhaust fans in toilet rooms.

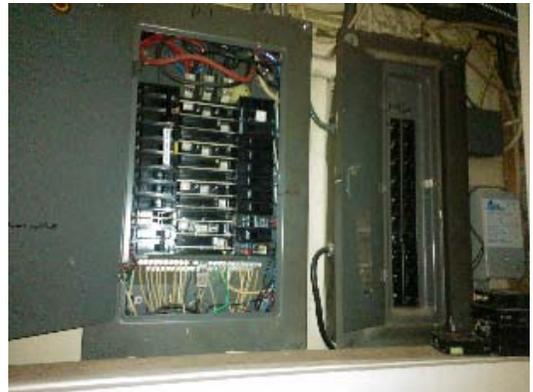
- The building is provided with a 120/208 volt, 3-phase service. Panels are obsolete and should be replaced. There are branch panels on both floors.
- Wiring includes the use of NM non-metallic type which needs to be removed to comply with current code.
- The building also has a 25 kW standby generator. A free-standing fuel storage tank is located in the generator room. When required power is transferred manually.
- The building is with a central fire alarm system. Pull stations are located at building exits, smoke detectors are provided in selected areas but not complete. Horn strobe annunciation is not provided in all rooms as required by code.
- There are some exit and emergency lights but coverage is incomplete.

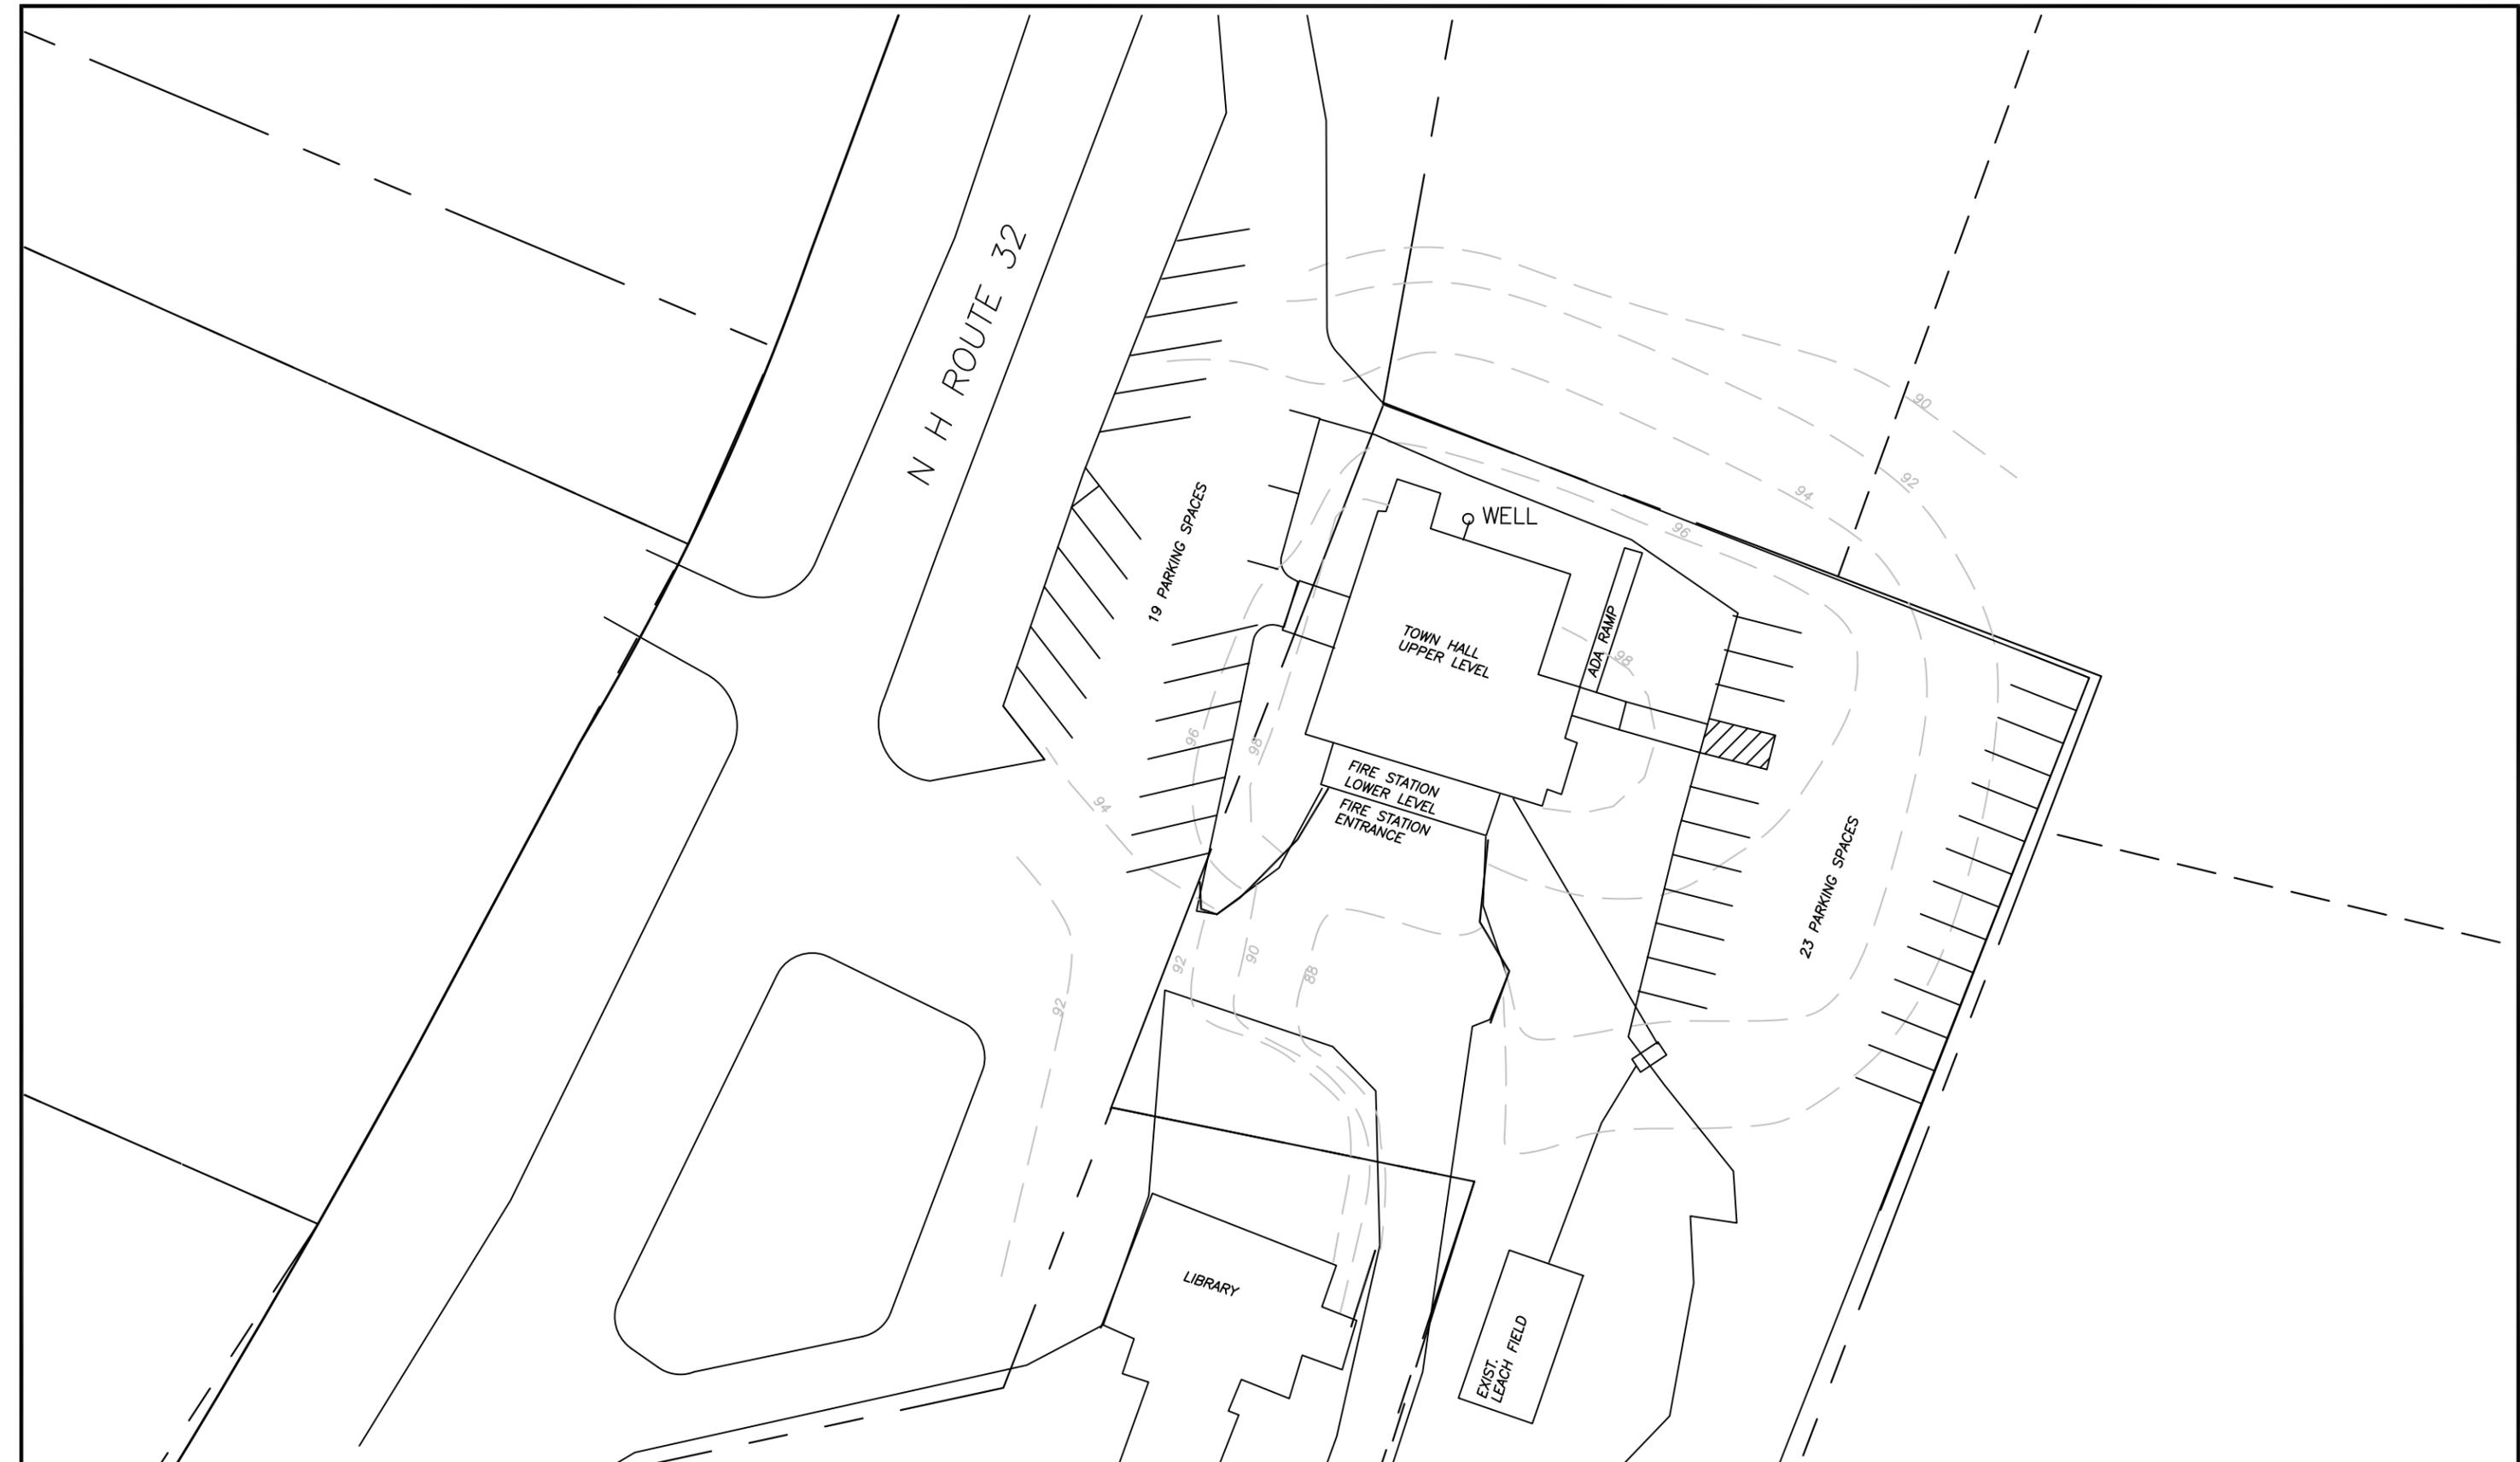
EXIST. PLOT PLAN

SWANZEY FIRE DEPARTMENT CENTRAL STATION
 AND TOWN HALL
 OLD HOMESTEAD HIGHWAY, SWANZEY, NH

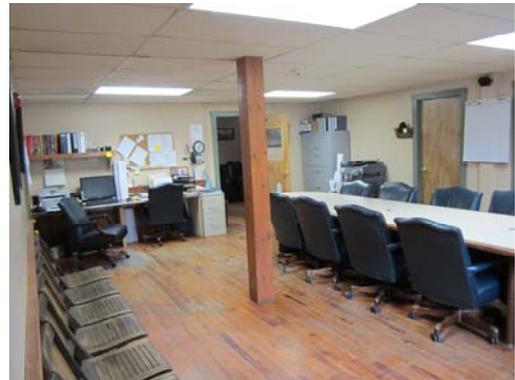
On the second floor, 4" diameter steel columns placed at the 3rd points in each direction of the original structure support the 2nd floor wood framing. The flat roof is framed with wood beams and roof joists. The roof structure is also supported off the same steel columns. The steel columns are very much structural. They cannot be removed. Although we could not see the floor and roof framing directly, they appear to be adequately supported for office loading and snow loading. Unusual cracks were not observed. A cut off beam could be seen running north to south in the rear access stairway.

16" deep open web steel bar joists spaced at 5' OC with 2" deep corrugated metal roof decking support the lower truck bay flat roof.

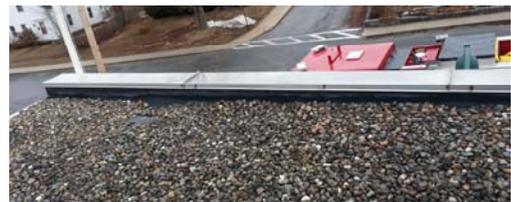
The stone ballasted roofing over the original building and the addition has reached its useful life. The stone and old roofing membrane/built up covering is scheduled for replacement with a contemporary light weight membrane soon. This work should be done. The insulation for both roofs needs to be investigated and improved. The roofs are capable of supporting additional insulation. There is a shed metal roof on the latest rear addition, with presumably cavity insulation within the roof framing.

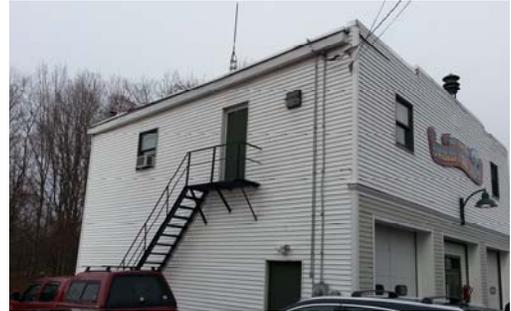
The 2nd floor steel fire escape on the east of the facility appears to be sound but is out of compliance because of its width 27" and it is not protected from the weather.

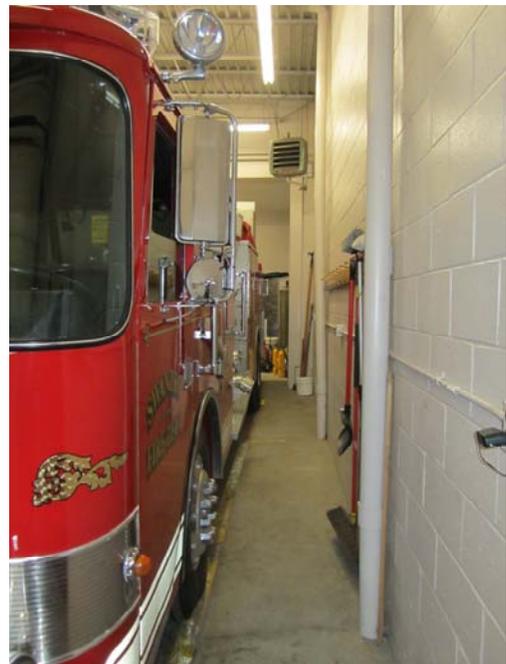
Because the original building was constructed so long ago, there is presumably no under-slab or below grade foundation wall insulation, which is required by today's energy code for new buildings. Insulation for the 12" exterior masonry walls appears to be limited to 2" of rigid polystyrene on the exterior masonry surfaces covered with a vinyl clapboard siding. Larger original windows are covered over, reportedly without any additional cavity insulation. This does not meet the current energy code, which requires continuous insulation with a minimum thermal resistance of R11.4 for masonry buildings. The new rear addition appears to be insulated with 6" fiberglass batt insulation. This also does not meet current code requirements of R3.8 of continuous insulation in addition to R-13 cavity insulation for wood framed building. The flat roof insulation for the main sections is unknown. The older building, and the small shed roof are likely insulated in the wood roof framing. The 2-bay steel roof insulation would be on the surface of the corrugated steel deck. The insulation needs to be investigated at the time when a new roof is installed. Current energy code requires a minimum of R20 continuous insulation above the roof deck. Upgrading the exterior wall and roof insulation could be easily accomplished on this building.

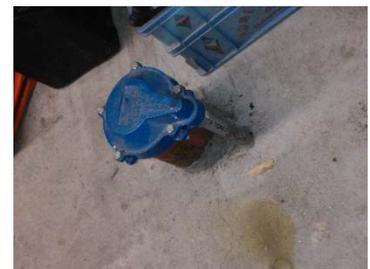
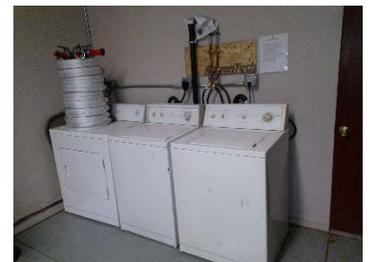
- The building has a well water service, the well head is located in the storage area behind the lower apparatus bay.
- The building is connected to the town sewer.

- There are area drains in the apparatus bays, there is no indication that the required oil/grit separate exists, and drains are reported to not be connected to the sanitary sewer.
- There are toilet rooms on both levels. Water closet are tank type, fixtures are not ADA compliant, and fixtures are in fair condition.
- A laundry tub is located in the boiler room, residential type laundry equipment is located at the back of the central apparatus bay.
- The kitchen on the upper level is also fitted with residential fixtures and appliances. A propane tank service is provided for the gas range.
- Truck hose wash faucets are provided in the apparatus bays. Faucets are not equipped with vacuum breaker.
- A shop air compressor is located at the lower apparatus bay.

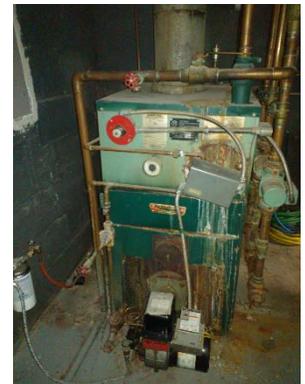
- The building is heated with an oil fired cast iron boiler, Peerless \pm 300 MBH built in 1990. The boiler is \pm 25 years old, indoor condition and at the end of its useful life.
- There are three pumping zones, the apparatus bays are heated with hot water unit heaters, and the upper floor has baseboard radiation. Thermostats are simple dual type, there are no provisions for automatic night setback.
- The building has no ventilation outside air systems as required by Code. Bathrooms do have ceiling mounted exhaust fans.
- There are no tailpipe exhaust systems for the fire equipment.

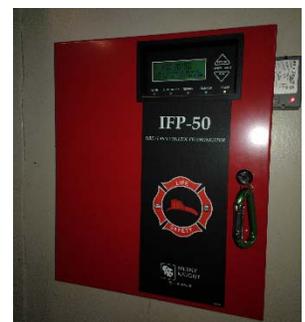
- The building is served with a 120/240 volt, single phase, and 200 amp panel. The utility meter is located on the exterior wall. Three phase is available on the street. Lighting throughout is primarily fluorescent, fixture have been updated and utilized T8 lamps. A time clock is provided for the exterior lighting.
- The building is protected with a fairly up-to-date fire alarm system, Silent Knight IFP-50. Fire pull stations are located at exterior doors, smoke detectors are placed throughout, and horn strobes are located in most rooms.
- Wiring appears to be either shielded or in conduit.

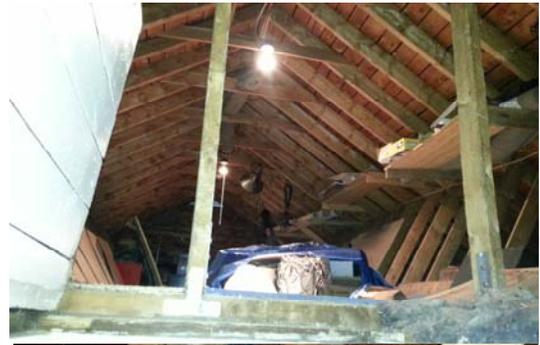
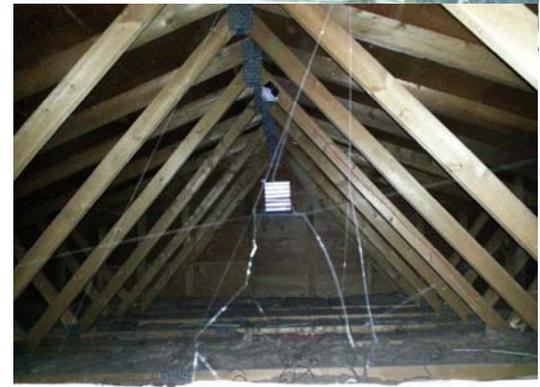
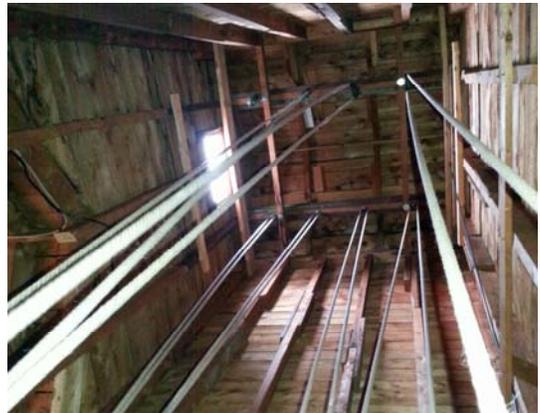
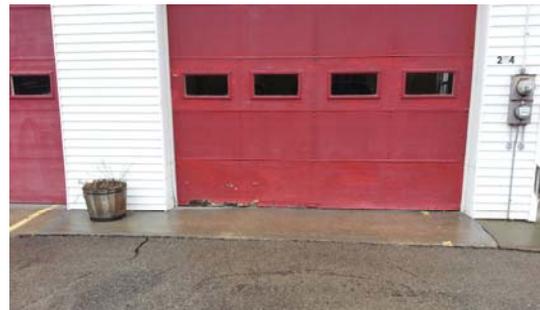
The hose drying tower should be removed. Energy loss would be reduced, roof framing would be improved, and the brick masonry chimney which is too close and short with respect to the tower would become appropriately located. The shallow pitch roof has a new membrane. The main truck bay and rear office area have new architectural grade asphalt shingles, replaced just last year. The roof coverings appear sound.

The exterior walls are covered in vinyl siding, which is in fair to good condition and damaged in several locations around the overhead doors. The overhead door trim needs to be replaced and protected. The overhead doors are also in poor condition and should be replaced and made wider.

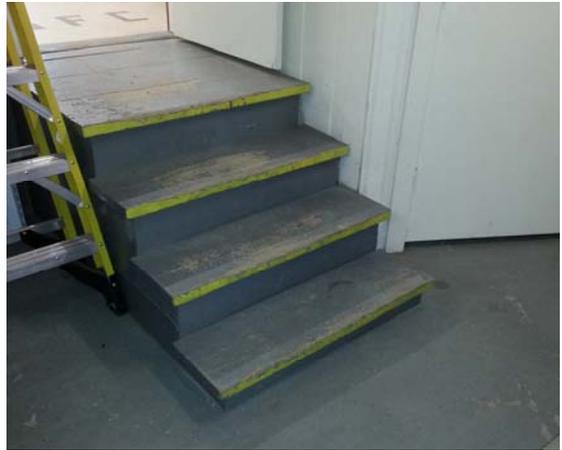
The difference in elevation between the office area and the truck bays is a problem. One can get grade access from the outside, however, internal access is a tough situation to improve, and the current building does not meet accessibility requirements in this regard. The bathroom is also much too small to meet accessibility requirements as well. The wall finishes of the apparatus bays are plastic / frp panels and the ceiling is a popcorn painted finish on gypsum board. There is water damage on the ceiling of the added apparatus bay from a previous roof leak that has since been repaired.

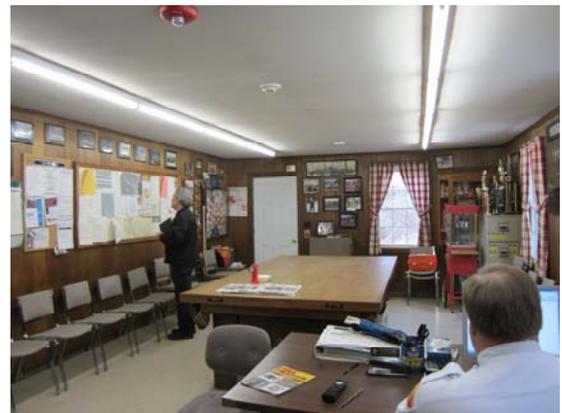
The upstairs meeting room is slab on grade, with VCT finish. The walls are covered in a wood panel vertical wainscot. The ceiling is a lay in 2x4 acoustical ceiling. There is a billiards table, refrigerator, microwave, and a single work station in this room. This is a volunteer station with no full time staff.

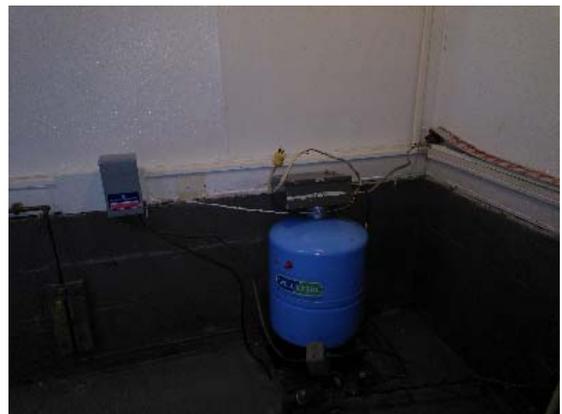
- This building has a domestic well water system, well head is located on the site in the grass section adjacent to the building.

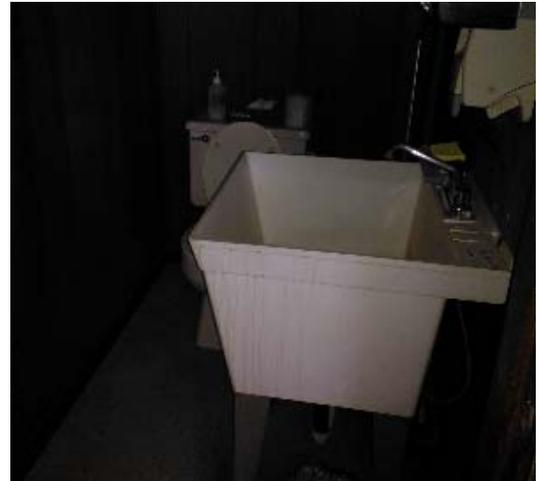
- Sanitary sewer is assumed to be an on-site disposal system, this needs to be confirmed.
- Truck wash-down stations do not have required volume breakers.
- There is one toilet room which includes a floor mounted tank toilet and laundry sink for the lavatory.
- Domestic hot water is heated via an electric storage unit.
- There are shop air and breathable compressed air system.

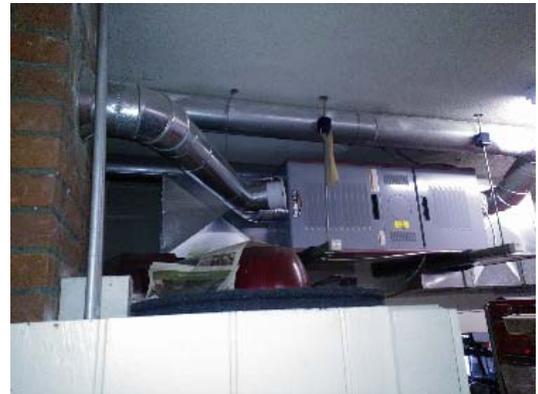
- The building is heated with a single oil fired furnace, unit appears to be \pm 2 years old and in good condition.
- There are no required apparatus bay exhaust or tail pipe exhaust system.
- The building is not air conditioned except for window units in the upper office/conference room.

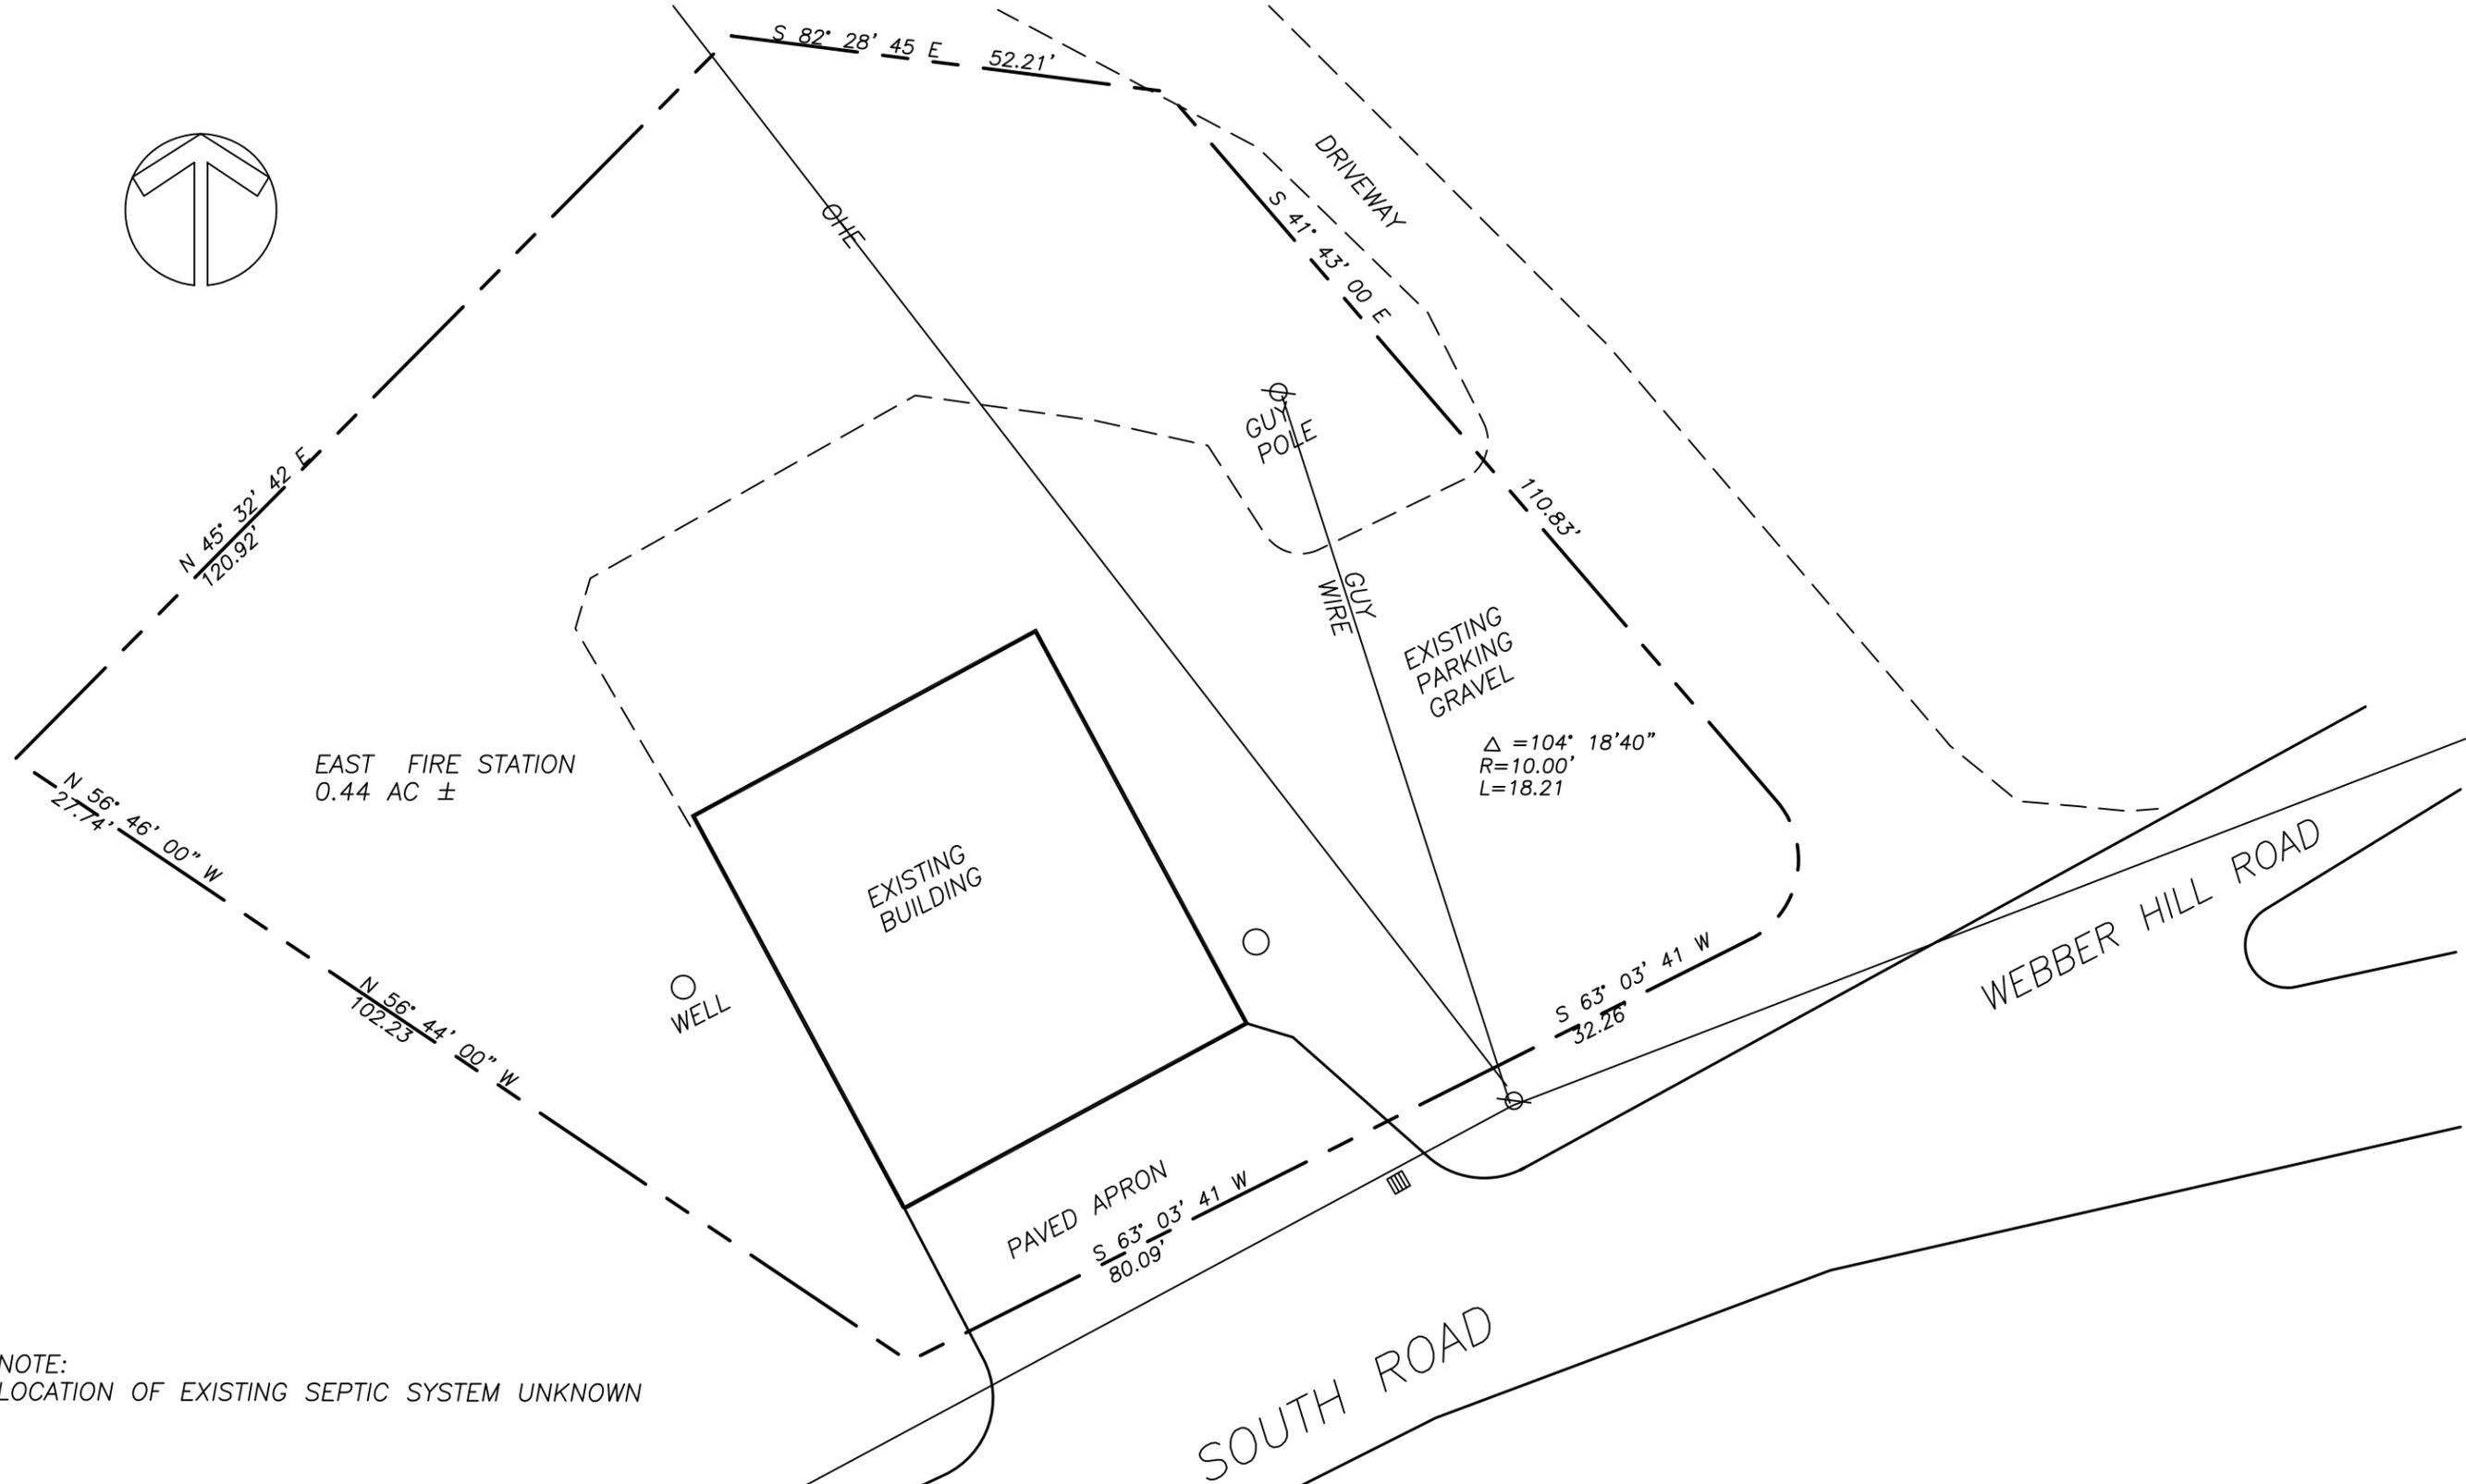
NOTE:
LOCATION OF EXISTING SEPTIC SYSTEM UNKNOWN

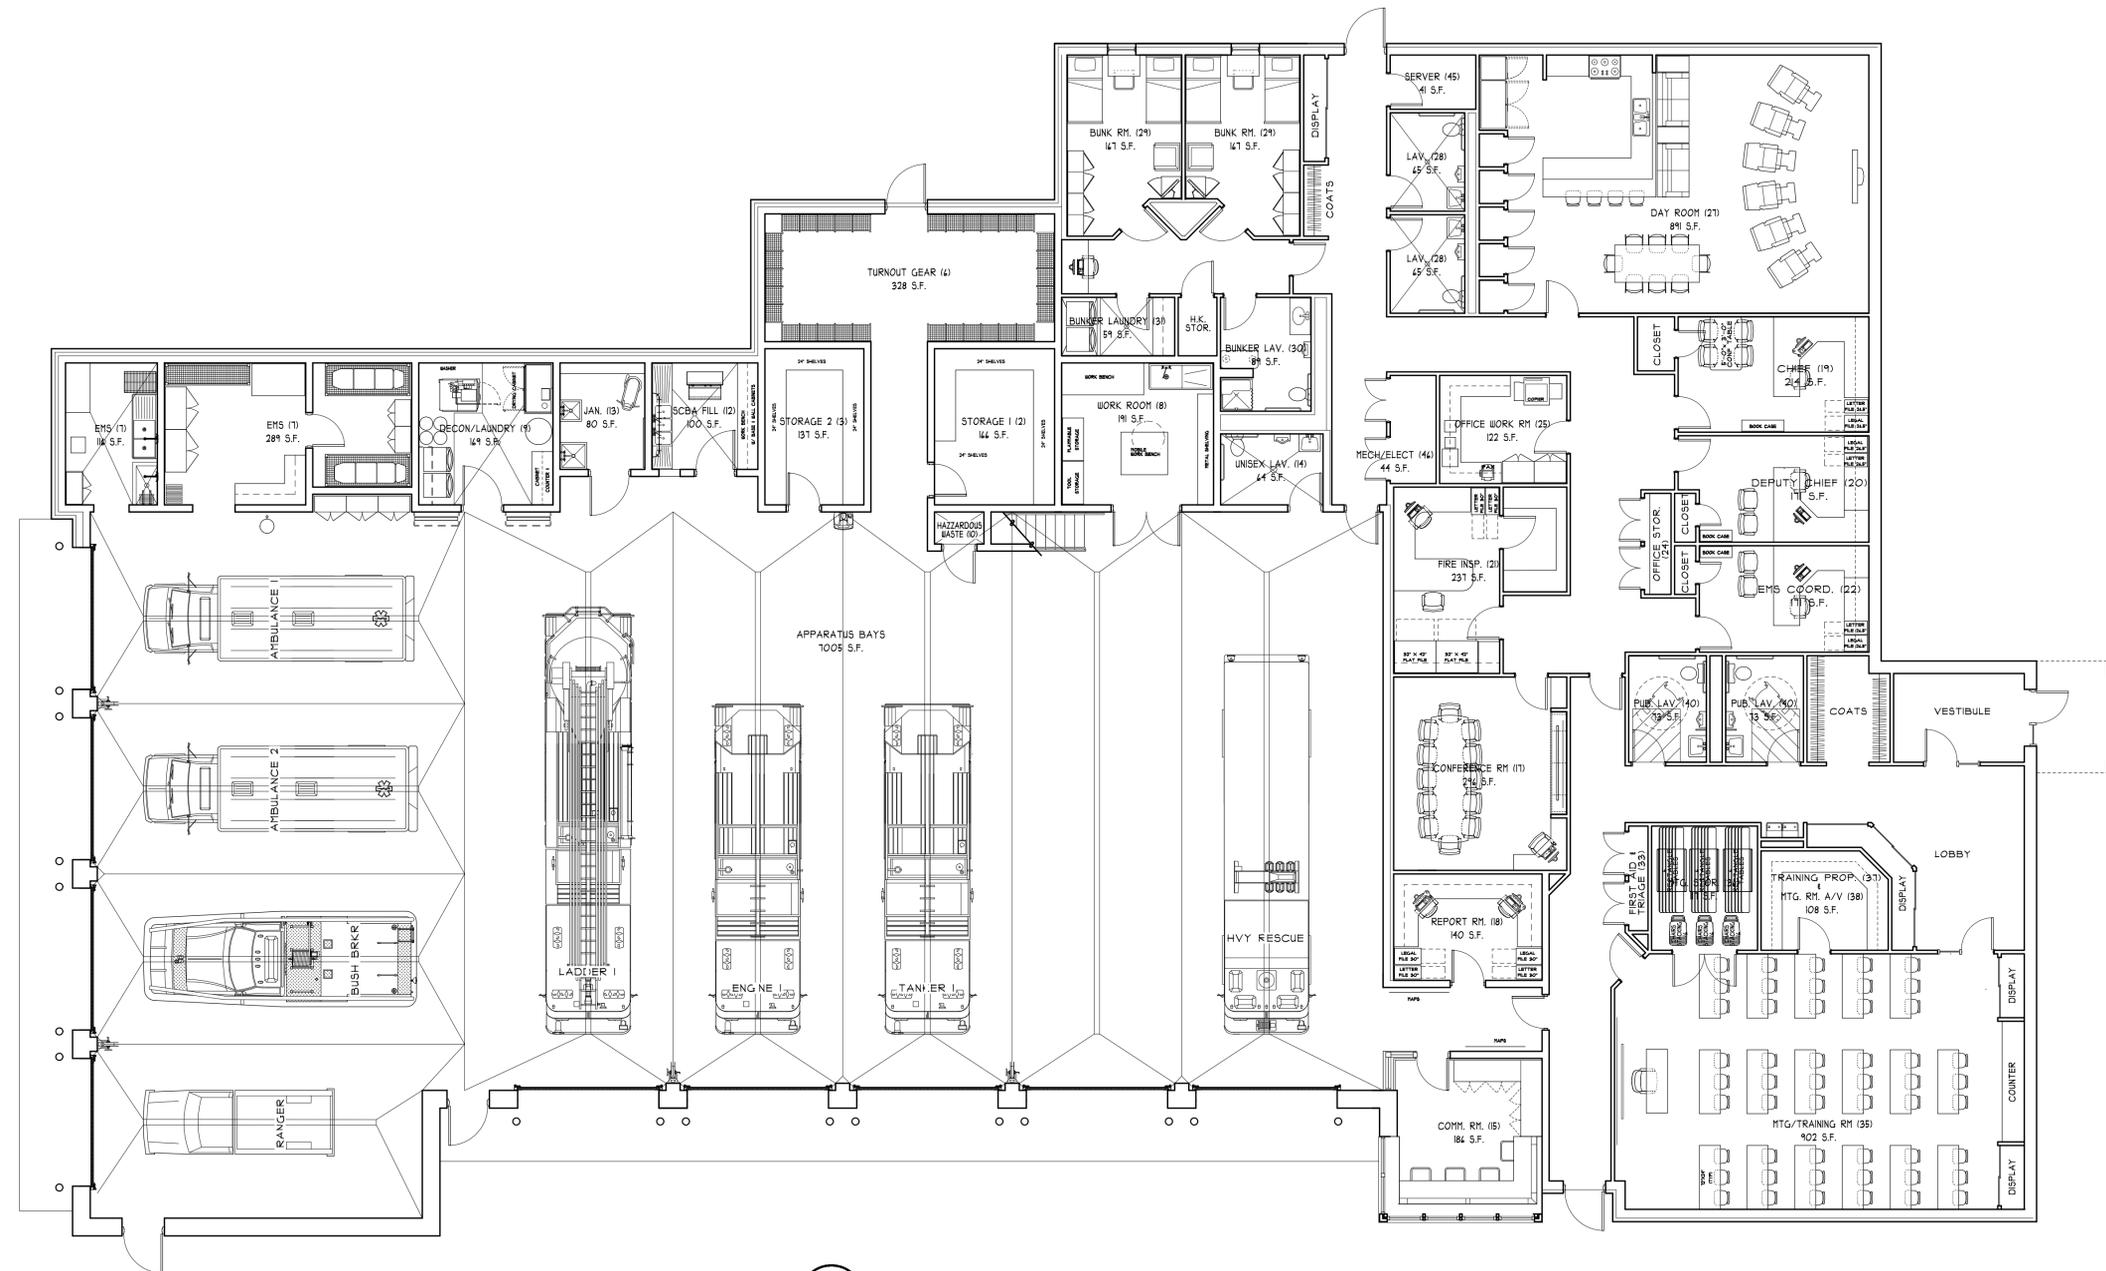
1 FLOOR PLAN
SCALE: 1/8" = 1'-0"

BUILDING AREAS	
FOOTPRINT	16,531
MEZZANINE	1,120
TOTAL	17,651
