4 - POLICE DEPARTMENT

May 14, 2014

Building Assessment for Existing Swanzey Police Department

34 Eaton Road
Swanzey, New Hampshire 03446

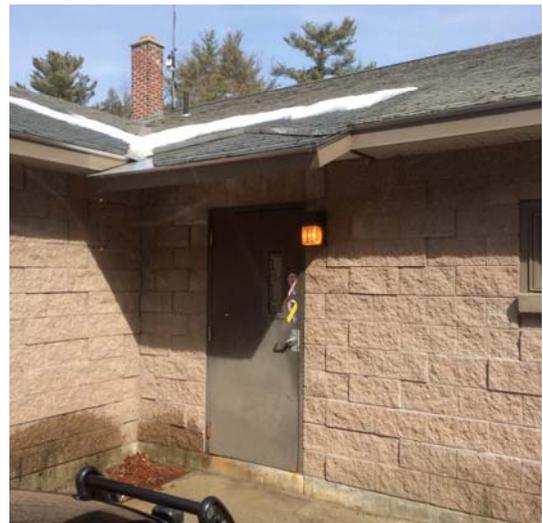
The 3-tab asphalt roof shingles are in poor condition and nearing their useful life. They need to be replaced relatively soon. There are vinyl roof soffits, gable siding and trim, that is in fair to good condition. There is roof drainage at the corner where the main roof meets the sally port, and at the other side of the sally port, intensified by the roof diverter and exacerbated where the drip edge of the roof is damaged. There is staining on the exterior block from splash back and the snow pile up. This has created the worst of the interior mold in this corner.

Doors are painted steel with lever handles. Windows are double glazed with clad exterior.

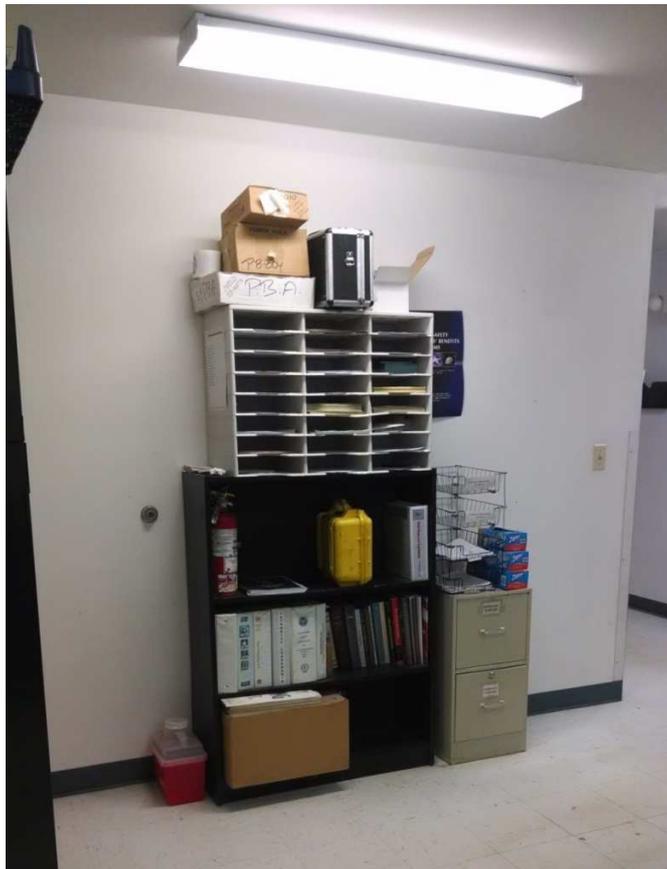
Photograph 10: Officer’s “Mailroom”

The patrol area lacks proper interview space.

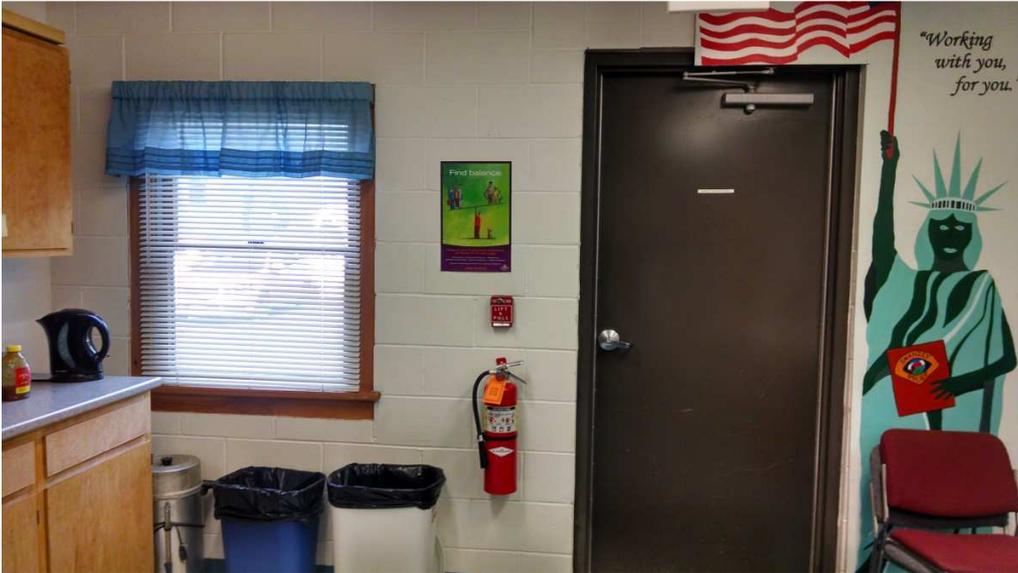
Photograph 21: Training Room – Parking Lot Entrance Door

Community groups use the training room often for meetings as do various town boards. Due to the lack of interview space, officers may use the space to interview suspects or victims and the space is improper for this purpose.
