A) BUILDING / SITE ASSESSMENT, WITH EXISTING SITE PLAN.

May 14, 2014

Building Assessment for the Existing Swanzey Department of Public Works

Pine Street
Swanzey, New Hampshire 03446

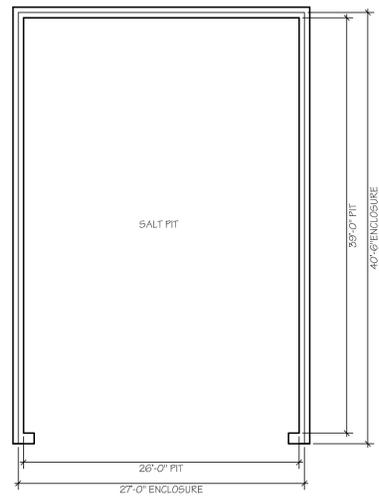
SALT SHED
SCALE: 1/8" = 1'-0"

- c. The salt shed is structurally in poor condition and also too small to meet current needs.
 - d. The salt dispenser storage is not ideally located, too small and unsafe.

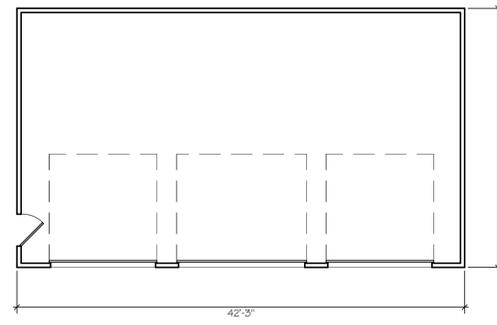
CEMETERY GARAGE
SCALE: 1/8" = 1'-0"

The wall construction of the garage appears to consist of uninsulated 2x6 wall framing, plywood sheathing, and vertical wood siding. The roof structure uses wood trusses with an uninsulated metal roof. The floor is a concrete slab on grade. The interior is exposed wall and roof framing and appears to be in very good/like new condition. The concrete slab appears to be in good shape as well. No water infiltration was evident.

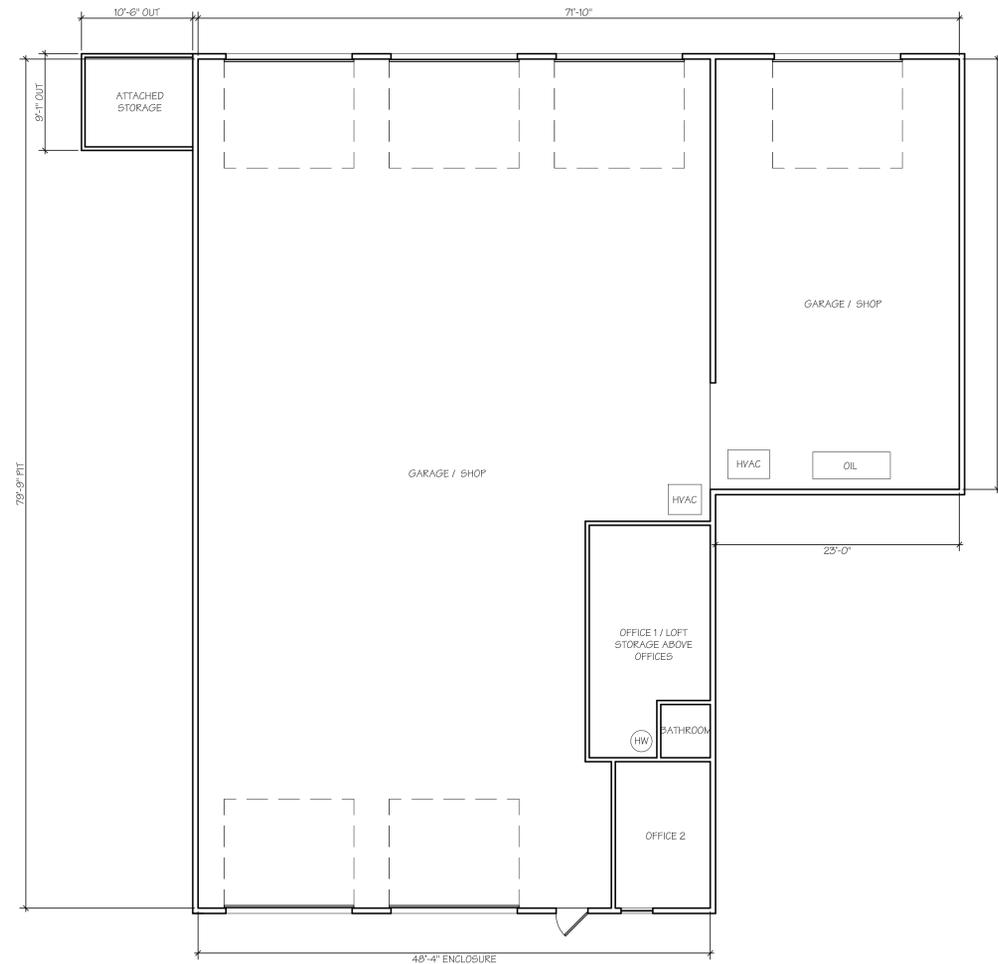
GARAGE, SHOP, OFFICES
SCALE: 1/8" = 1'-0"

The interior of the DPW Garage/Office building appears to need some maintenance and upgrades. The exterior walls of the steel framed metal building are insulated with fiberglass blanket insulation, thickness is unknown at this moment. The fiberglass insulation appears to be intact in most locations, however, there are some areas where insulation has been removed or let loose. Daylight could be visibly seen through several pea size holes in the exterior walls. These holes allow heated air to escape and possibly allow water into the building envelope. No holes or leaks were visible in the roof, however, the fiberglass blanket insulation was covering most of the roof deck. The concrete floor slab appeared to be in fair condition given its usage, however, could benefit from a good cleaning. The offices consist of wood framed walls, sheathed with OSB on the garage side and finished with a combination of composite material and gypsum wallboard. at the office interior. The interior of one office houses a bathroom which appears to be undersized for its purpose. The interior office finishes appeared to have a dust/sand mixture coating, possibly from dirt infiltration from the garage. The office and bathroom are overcrowded and do not meet accessibility requirements for public spaces. Additionally, electrical panels and water heaters are located in the break / conference room, and should be located in a separate mechanical room, and given proper clearances. The finishes themselves appear to be outdated. There are issues with snow run off from the vehicles in the garage off coming into office areas and a trench drain or separator of some kind is needed. A fire separation between these spaces is also required, with fire doors, to meet basic life safety codes. Above the offices is a storage loft. There appeared to be locations that were missing railings, and the access to the storage area is not code compliant.
