### **6 - RECYCLING CENTER**

**A) BUILDING / SITE ASSESSMENT, WITH EXISTING SITE PLAN.**

May 14, 2014

## Building Assessment for the Existing Swanzey Recycling Center

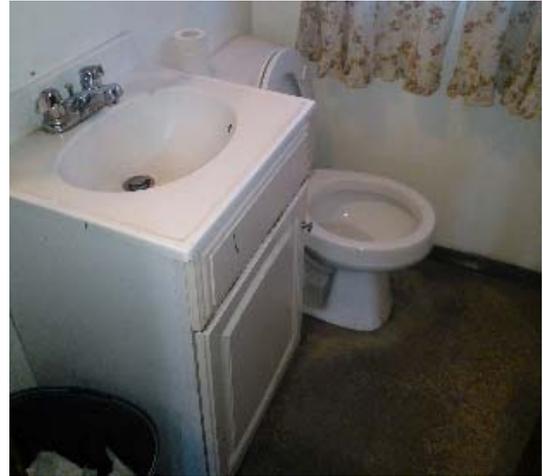
- The building shares a well water system with the Town garage across the street.
- The building has a connection to the Town garages on site disposal system.
- There is a small toilet room with one water closet and a vanity top lavatory. A 5 gallon electric water heater serves the lavatory.

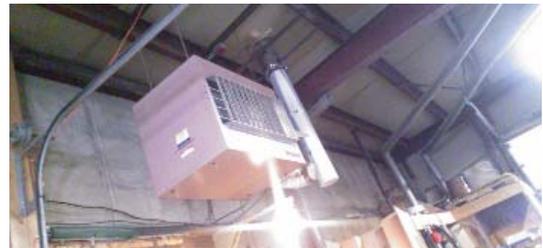
- The building has a waste oil space heater and conventional oil fired furnace. The waste oil heater is the primary source of heat.
- There is a manually operated wall exhaust fan.

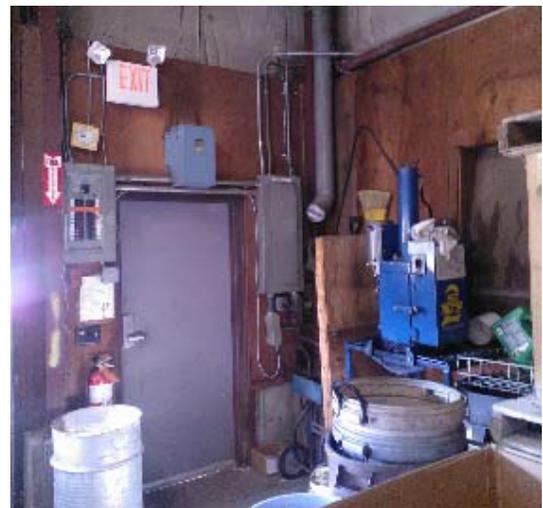
- The building has a 120/208 volt, 3-phase, 200 amp electric service and a 120/208 volt, single phase subpanel.
- Lighting is strip fluorescent type, fixtures were upgraded to T8 lamps.
- There is no fire alarm system.
- Combination emergency/exit lights are located at the exterior doors. There is no outside emergency lighting.
- The adjacent shed buildings have lighting only, sub-feed from the recycling center.
